## Dilapidation Inspection Report

Inspection Date: Thu, 9 Apr 2026

Property Address: 30 Beach St, Ettalong Beach NSW 2257,  
Australia

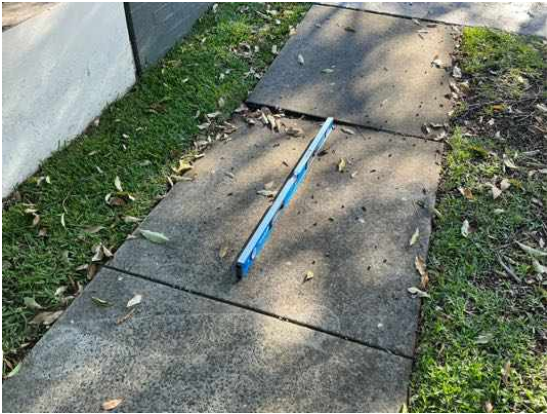
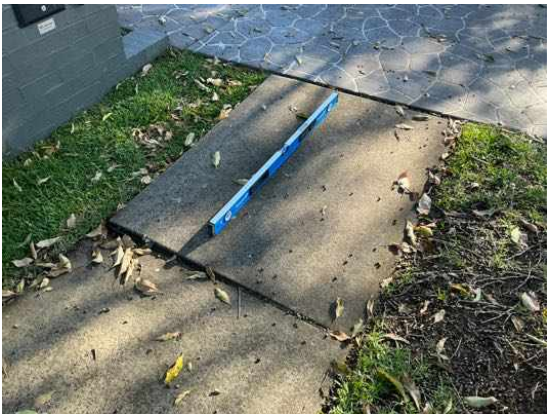
| Information: | At the time of inspection, subsidence was noted in sections of the external footpath located at the front area of the property. A digital level was used to confirm slope variations, which recorded measurable deviations from level (examples shown in accompanying photos). The subsidence may pose a potential trip hazard and can also lead to water pooling or uneven surface wear over time. This condition should be monitored during construction activities, particularly if heavy machinery or increased foot traffic is expected, to ensure no further deterioration or safety risks occur. |

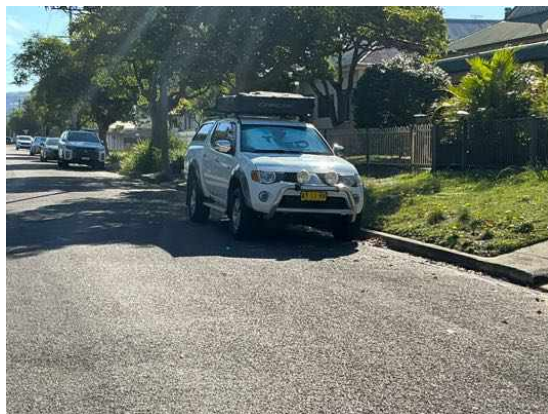
| Information: | These photographs are an indication of the obstructions and limitations which impeded full inspection of the property at the time of inspection. These obstructions can hide an array of defects and should be removed to allow full inspection to be carried out. A re-inspection is recommended once the areas are made accessible. |

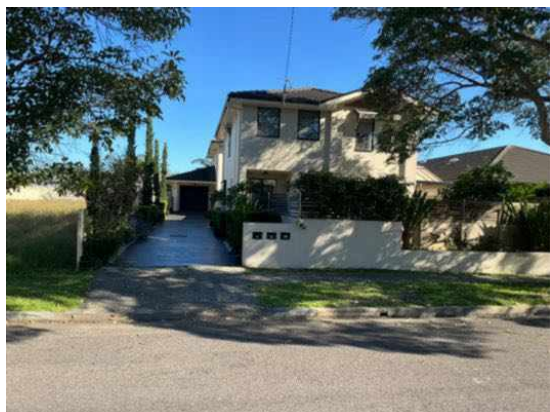
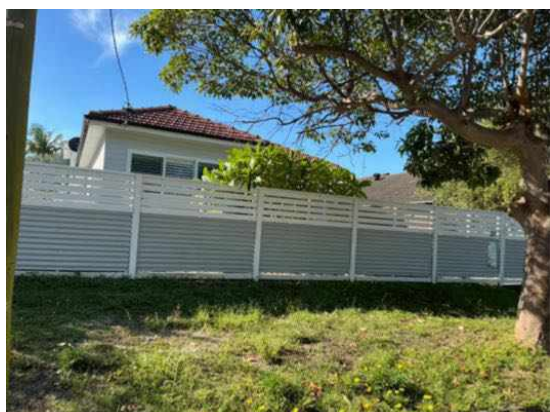
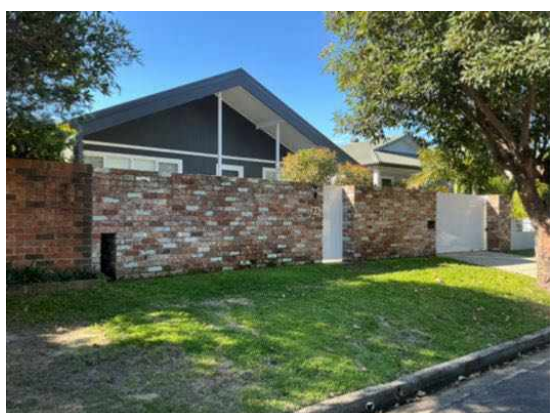
| Information: | At the time of inspection, the provided image serves as a reference point for all council assets documented in this dilapidation report, covering both the left side and right side of the area. The assessment includes footpaths, kerbs, driveways, road surfaces, |

drainage infrastructure, and the bus stop shelter, ensuring that their current condition is recorded prior to any nearby construction or development activities. This documentation will assist in identifying any potential changes or damages that may occur as a result of external works.

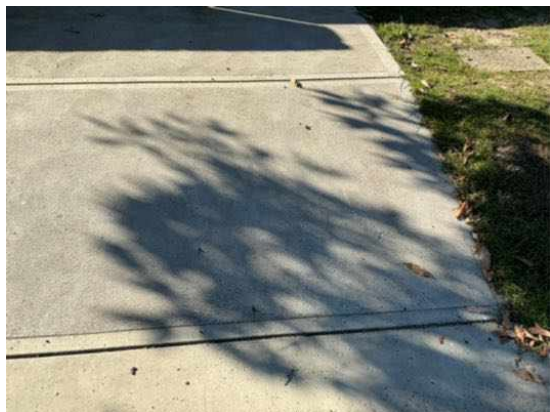
| Information: | Cracking and deterioration of the concrete slab in this area were observed during the inspection. These types of cracks are typically consistent with general wear, dilapidation, and the natural ageing of the structure. If left unaddressed, the deterioration may progress over time, potentially leading to further damage. |

At the time of the inspection, the cracks exhibited varying sizes and widths, indicating differing stages of development. It is recommended that regular monitoring be undertaken to assess any progression of the cracking and to identify potential future maintenance requirements.

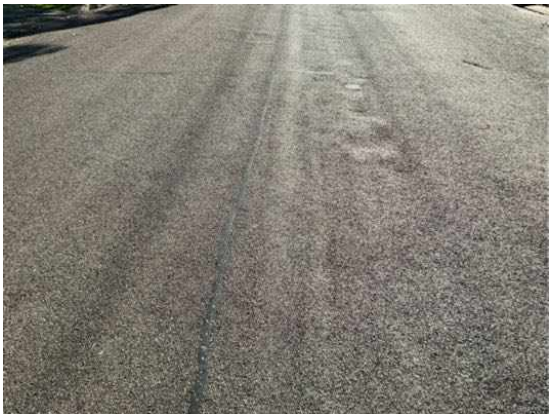
Building: Main Building  
Location: Road Carriageway or Roadway Middle  
Finding: Roadway Asphalt (Dilapidation)  
Information: At the front of the property there were clear signs of minor cracking and 'spiderwebbing' to the asphalt in the area at the time of inspection.

This type of cracking is often consistent with general dilapidation of the area, and may continue to develop if left unmaintained.

At the time of the inspection, the cracking in this area is in varying sizes and widths as noted in these images. Frequent monitoring should be carried out to identify any further damage.

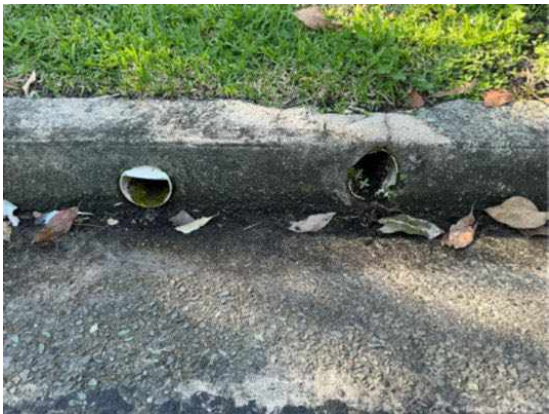
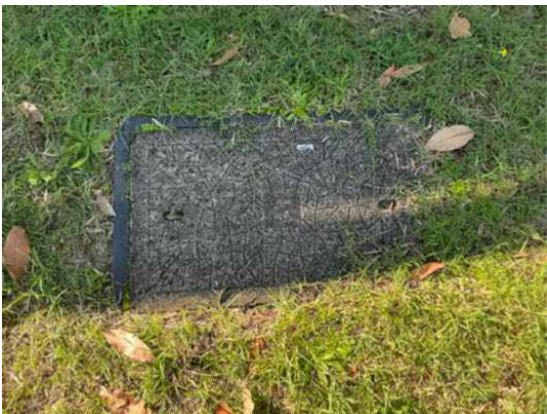
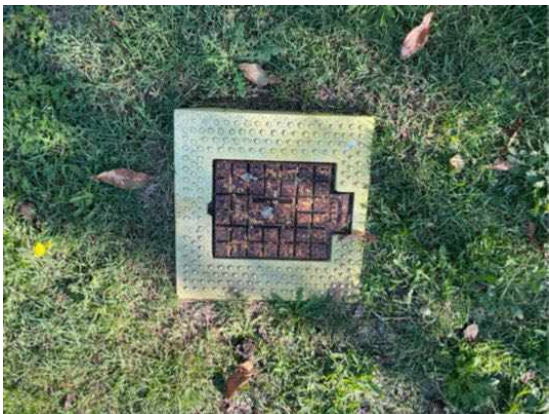
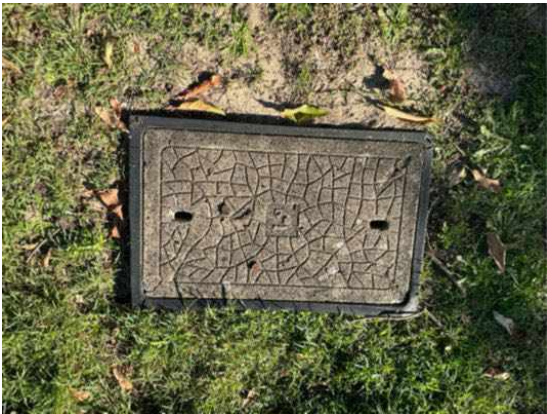
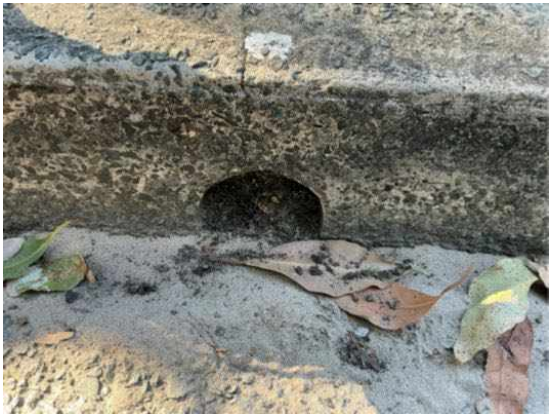
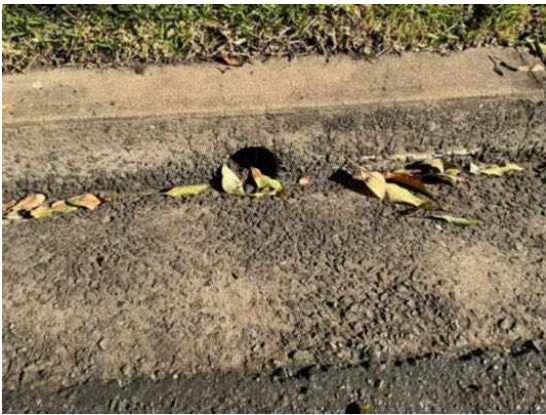
| Finding: | Service Pits/Drains Condition (Dilapidation) |

This type of subsiding is often consistent with general dilapidation of the property, and may continue to develop if left unmaintained.

At the time of inspection, the service pits are as per the photos attached. Frequent monitoring should be carried out to identify any further damage.

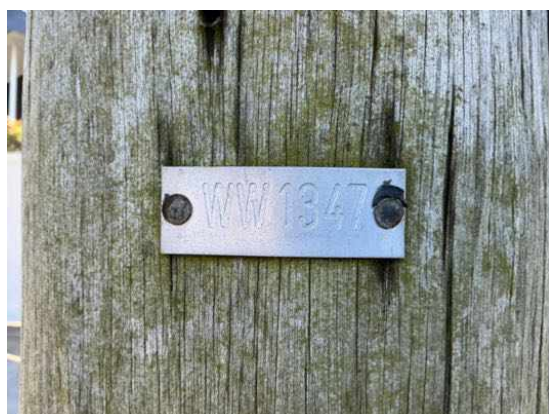
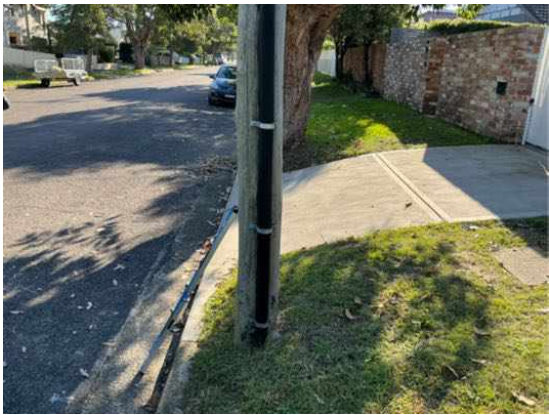
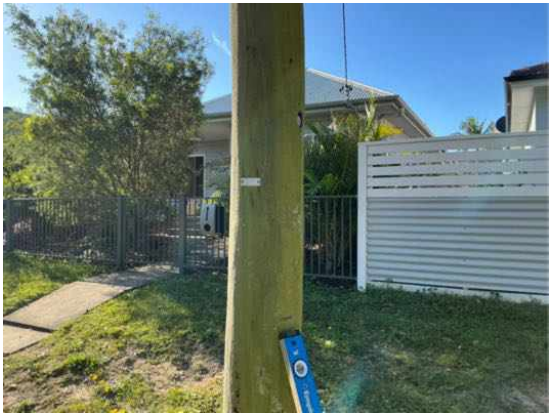
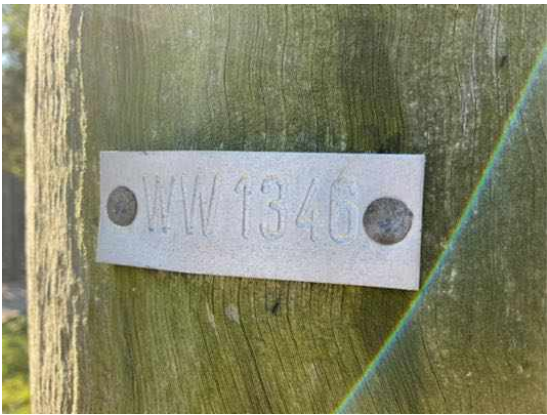
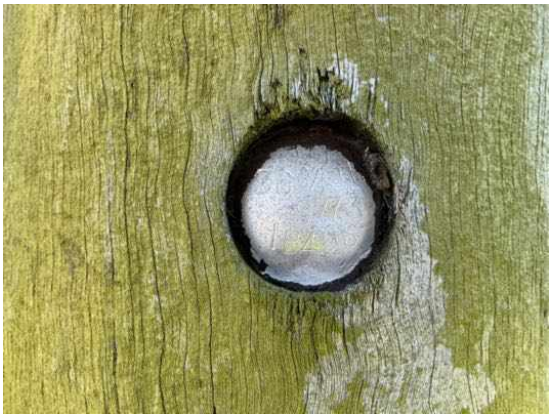
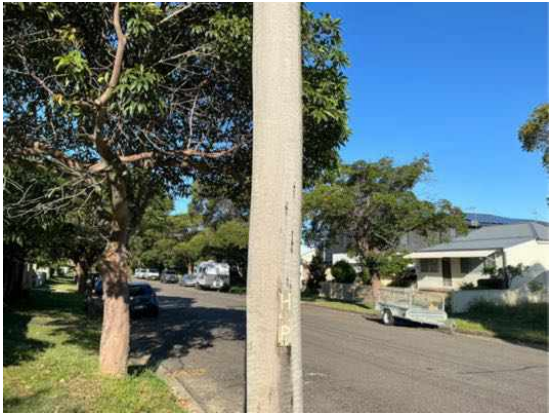
| Information: | <p>The telegraph poles along the street were visually inspected as part of this dilapidation report. Observations were limited to accessible and visible aspects of the poles and excluded any underground or concealed structural elements. The condition of the telegraph poles varied, with some displaying general wear and deterioration consistent with exposure to environmental factors such as weathering, moisture, and UV exposure.</p> <p>Common observations included surface wear, minor cracking, peeling or faded</p> |

protective coatings, and localised areas of staining or discolouration. In some cases, evidence of rust on metal components or minor degradation at the base of the poles was noted, which may warrant further investigation. No significant structural defects or immediate safety concerns were identified at the time of inspection.

This assessment is based on a visual inspection only and reflects the condition of the telegraph poles at the time of the report. Regular monitoring and maintenance by the responsible authority are recommended to ensure the ongoing safety and functionality of the poles. Photographic evidence has been included to document the condition of the poles and highlight any areas of concern.

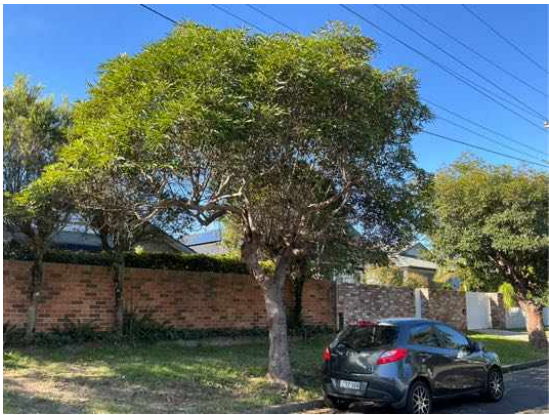
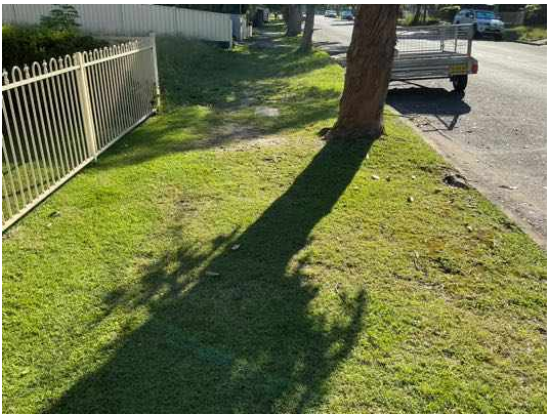
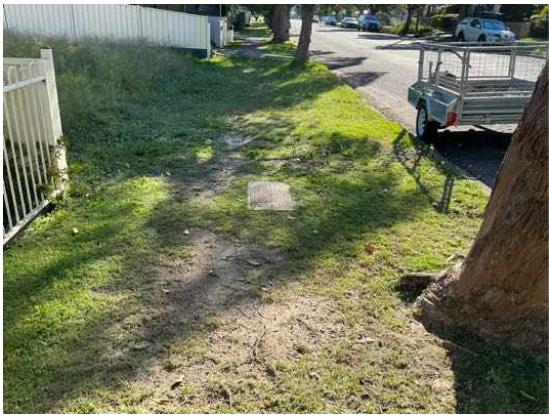
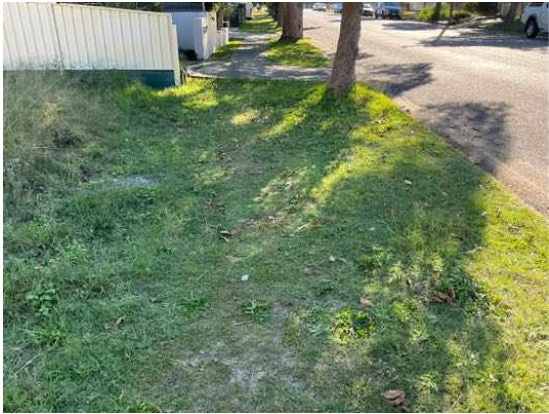
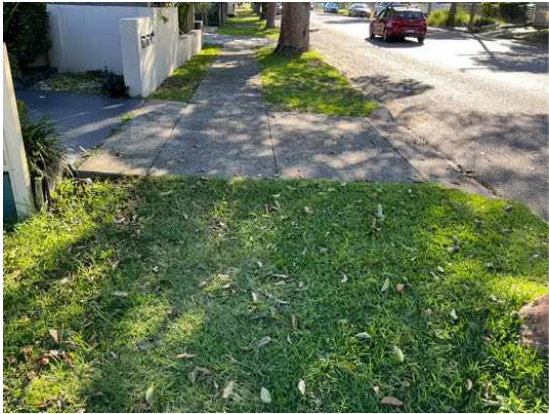
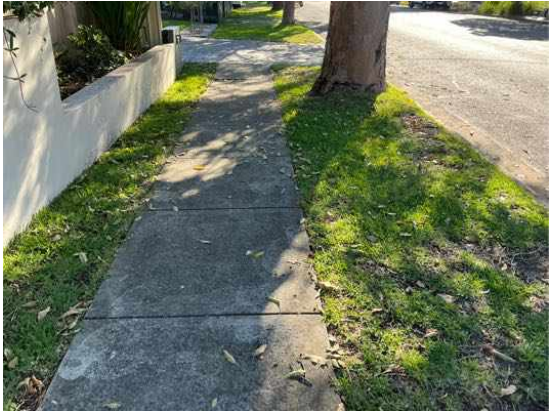
| Finding: | Trees, Plants, Garden Beds Condition |
| Information: | The trees, plants, and garden beds outside the property were visually inspected as part of this dilapidation report. Observations were limited to visible conditions and excluded subsurface or root system issues. Minor wear consistent with age and environmental exposure was noted, including displaced soil, dead branches, and natural pruning. Regular maintenance, including trimming and soil care, is recommended. Photographs have been included to highlight areas of note. |

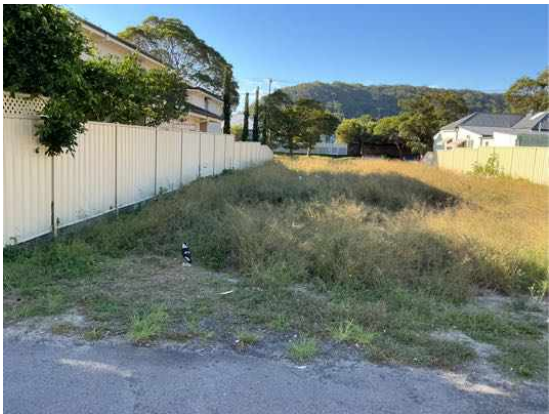
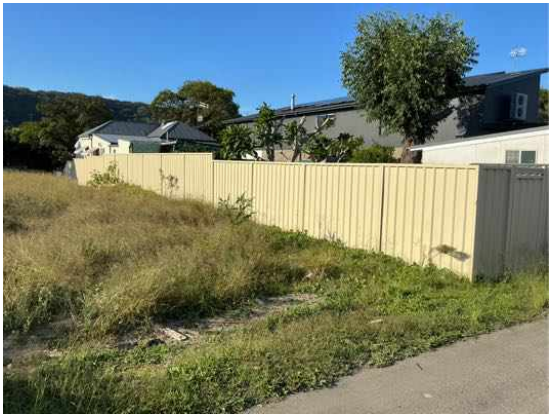
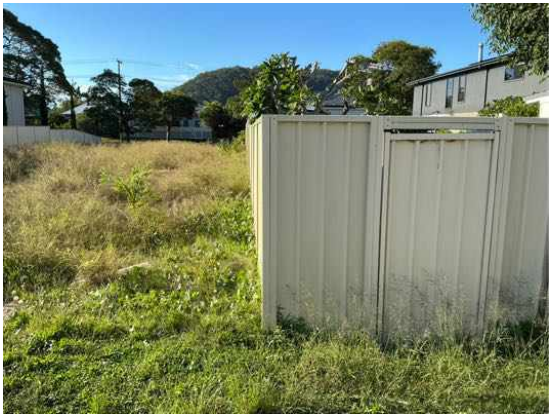
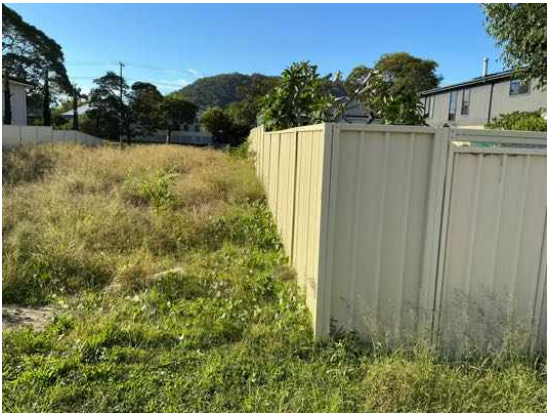
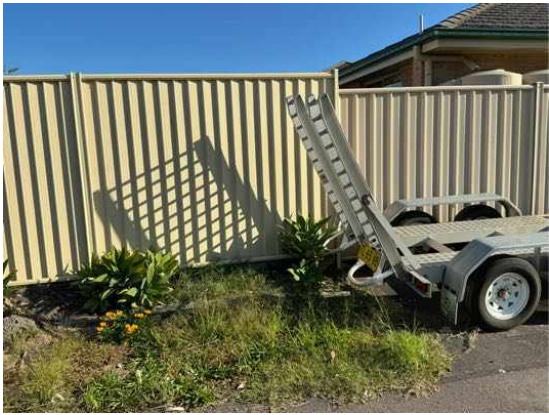
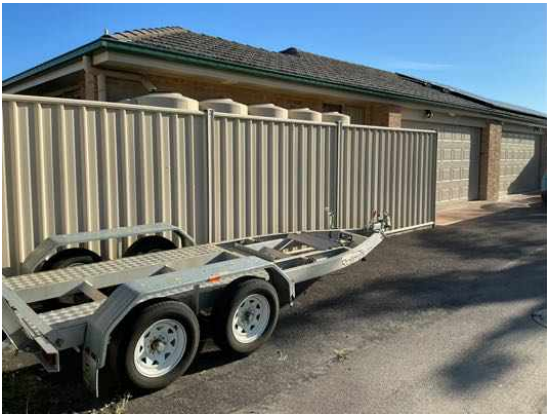
Building: Main Building  
Location: Back Lane  
Finding: FYI – General Condition of Back Lane  
Information: At the time of inspection, the back lane including roadways, fencing, and surrounding elements appeared to be in generally serviceable condition with typical signs of wear and tear noted.

These observations are provided for documentation purposes as part of the dilapidation report. The client is advised to monitor these areas during and after any nearby construction works to identify any changes or damage that may occur.
