# Arboricultural Impact Assessment

Site Address: 121 Memorial Ave Ettalong Beach NSW

Date: March 2024

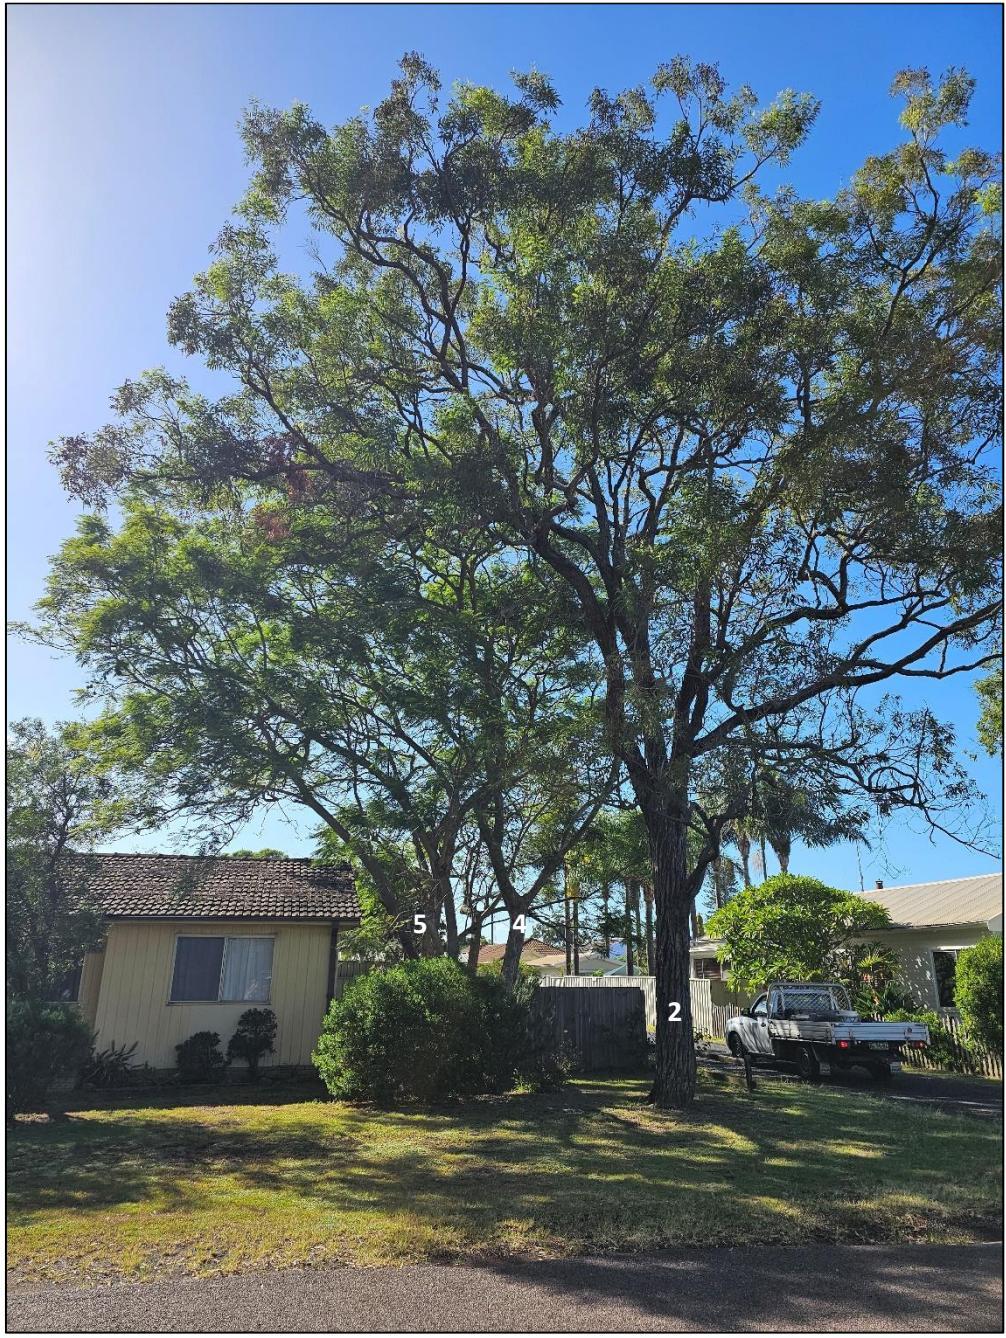
Figure 1 Trees 2 Angophora floribunda, 4 and 5 Jacaranda mimosifolia.

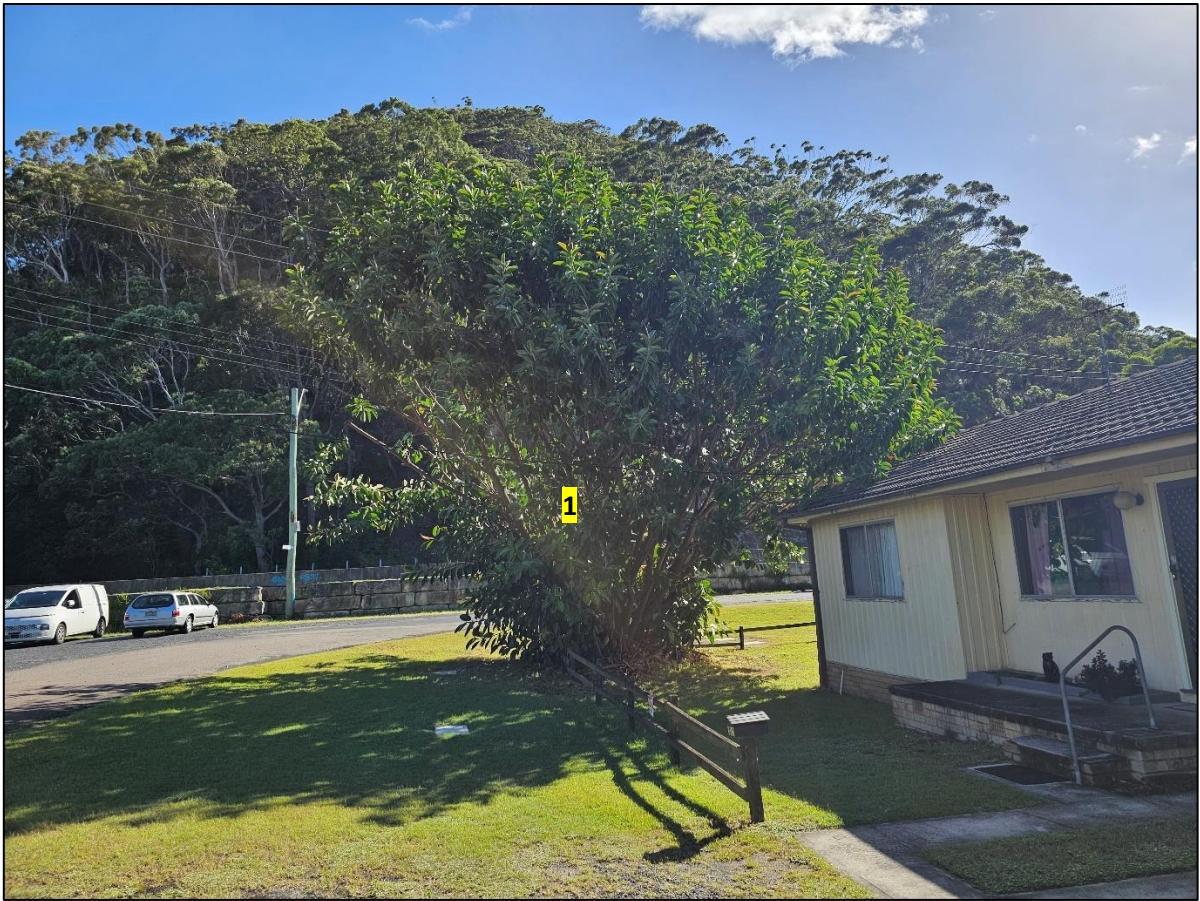
Tree 1 *Ficus elastica* appears in good health and condition and is assessed with moderate retention value. The tree is located on the road reserve at the front of the property and will be retained in conjunction with the proposed development.

The tree will be subject to a minor and acceptable level of encroachment caused by construction of the proposed Unit 1 and will be protected by the installation of temporary fencing panels to establish an exclusion zone 4 metres radius from the nominal centre of the trunk.

Figure 3 Tree 1 Ficus elastica.

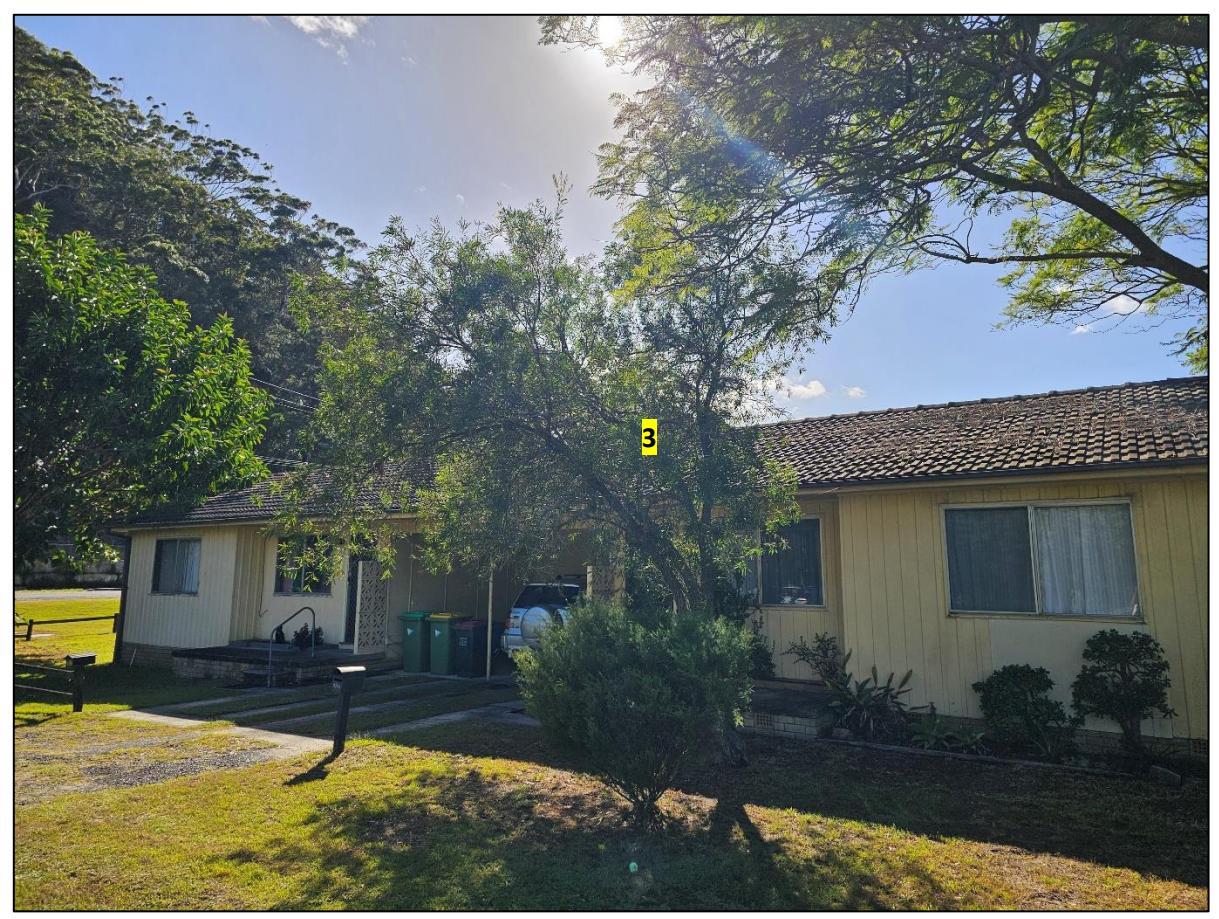
Trees 3 *Callistemon citrinus*, 4 and 5 *Jacaranda mimosifolia* are located within 3 metres of the existing dwelling and are therefore eligible for removal under Councils exempt removal criteria which are detailed in CCDCP Chapter 3.5 Section 3.5.3.2.a. The trees will be removed during the demolition stage of the development.

Figure 4 Tree 3 *Callistemon citrinus*.

That Trees 3 *Callistemon citrinus*, 4 and 5 *Jacaranda mimosifolia* will be removed during the demolition phase of the proposed development.

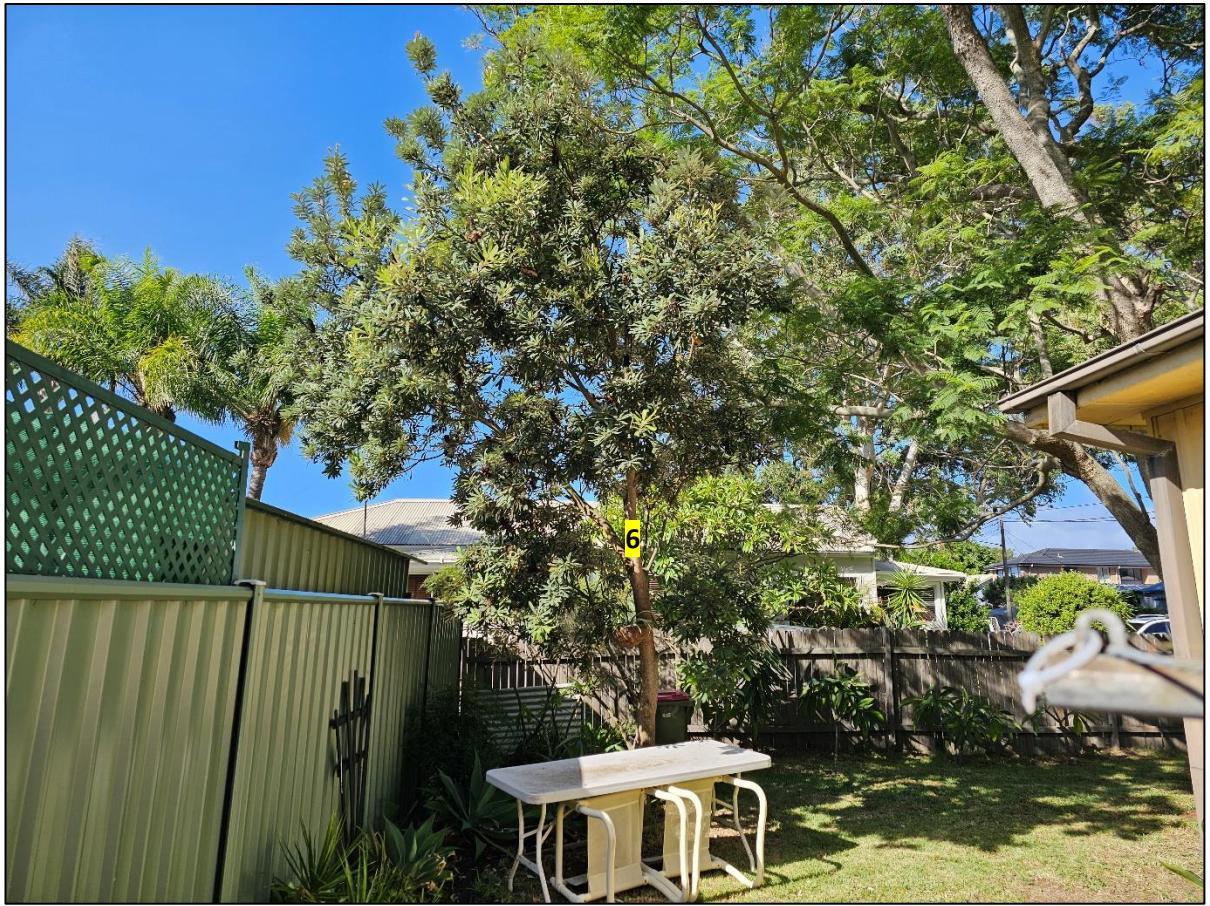
Tree 6 is a semi-mature native tree located in the rear yard of the subject property that appears in good health and vigour and is assessed with moderate retention value.

The tree will be subject to a manageable level of encroachment caused by the construction of the proposed Unit 3 and will be protected by the installation of temporary fencing panels at 2-metres radius from the centre of the trunk to establish an exclusion zone.

Figure 5 Tree 6 Banksia integrifolia.

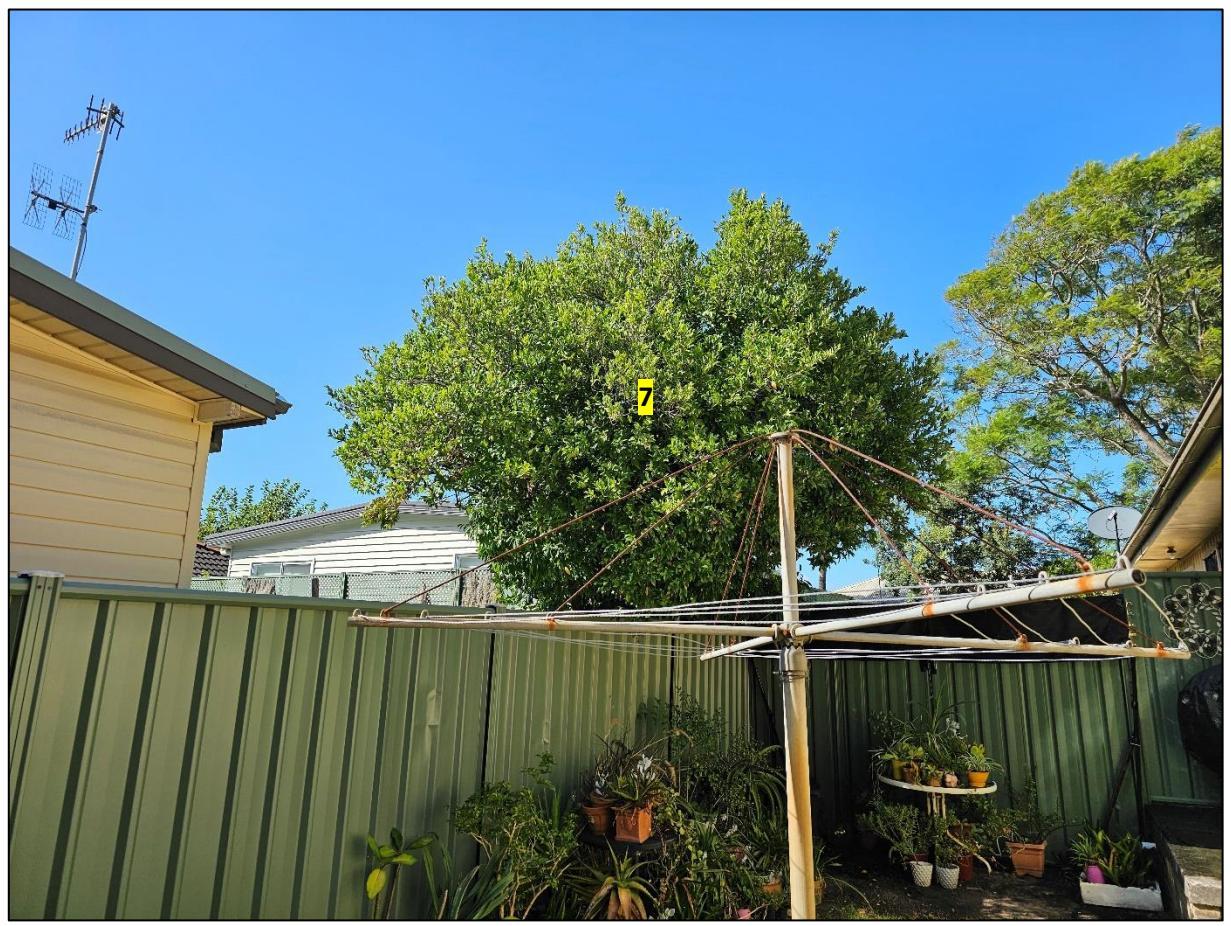
Tree 7 is a semi-mature exotic tree located against the boundary on the adjoining property to the East that appears in good health and vigour and is assessed with moderate retention value.

The tee will be subject to a minor and acceptable level of encroachment caused by the construction of the proposed Unit 2 and will be adequately protected by retention of the existing boundary fence. The fence is to be maintained in serviceable condition for the duration of the project.

Figure 6 Tree 7 *Magnolia figo* on the adjoining property.

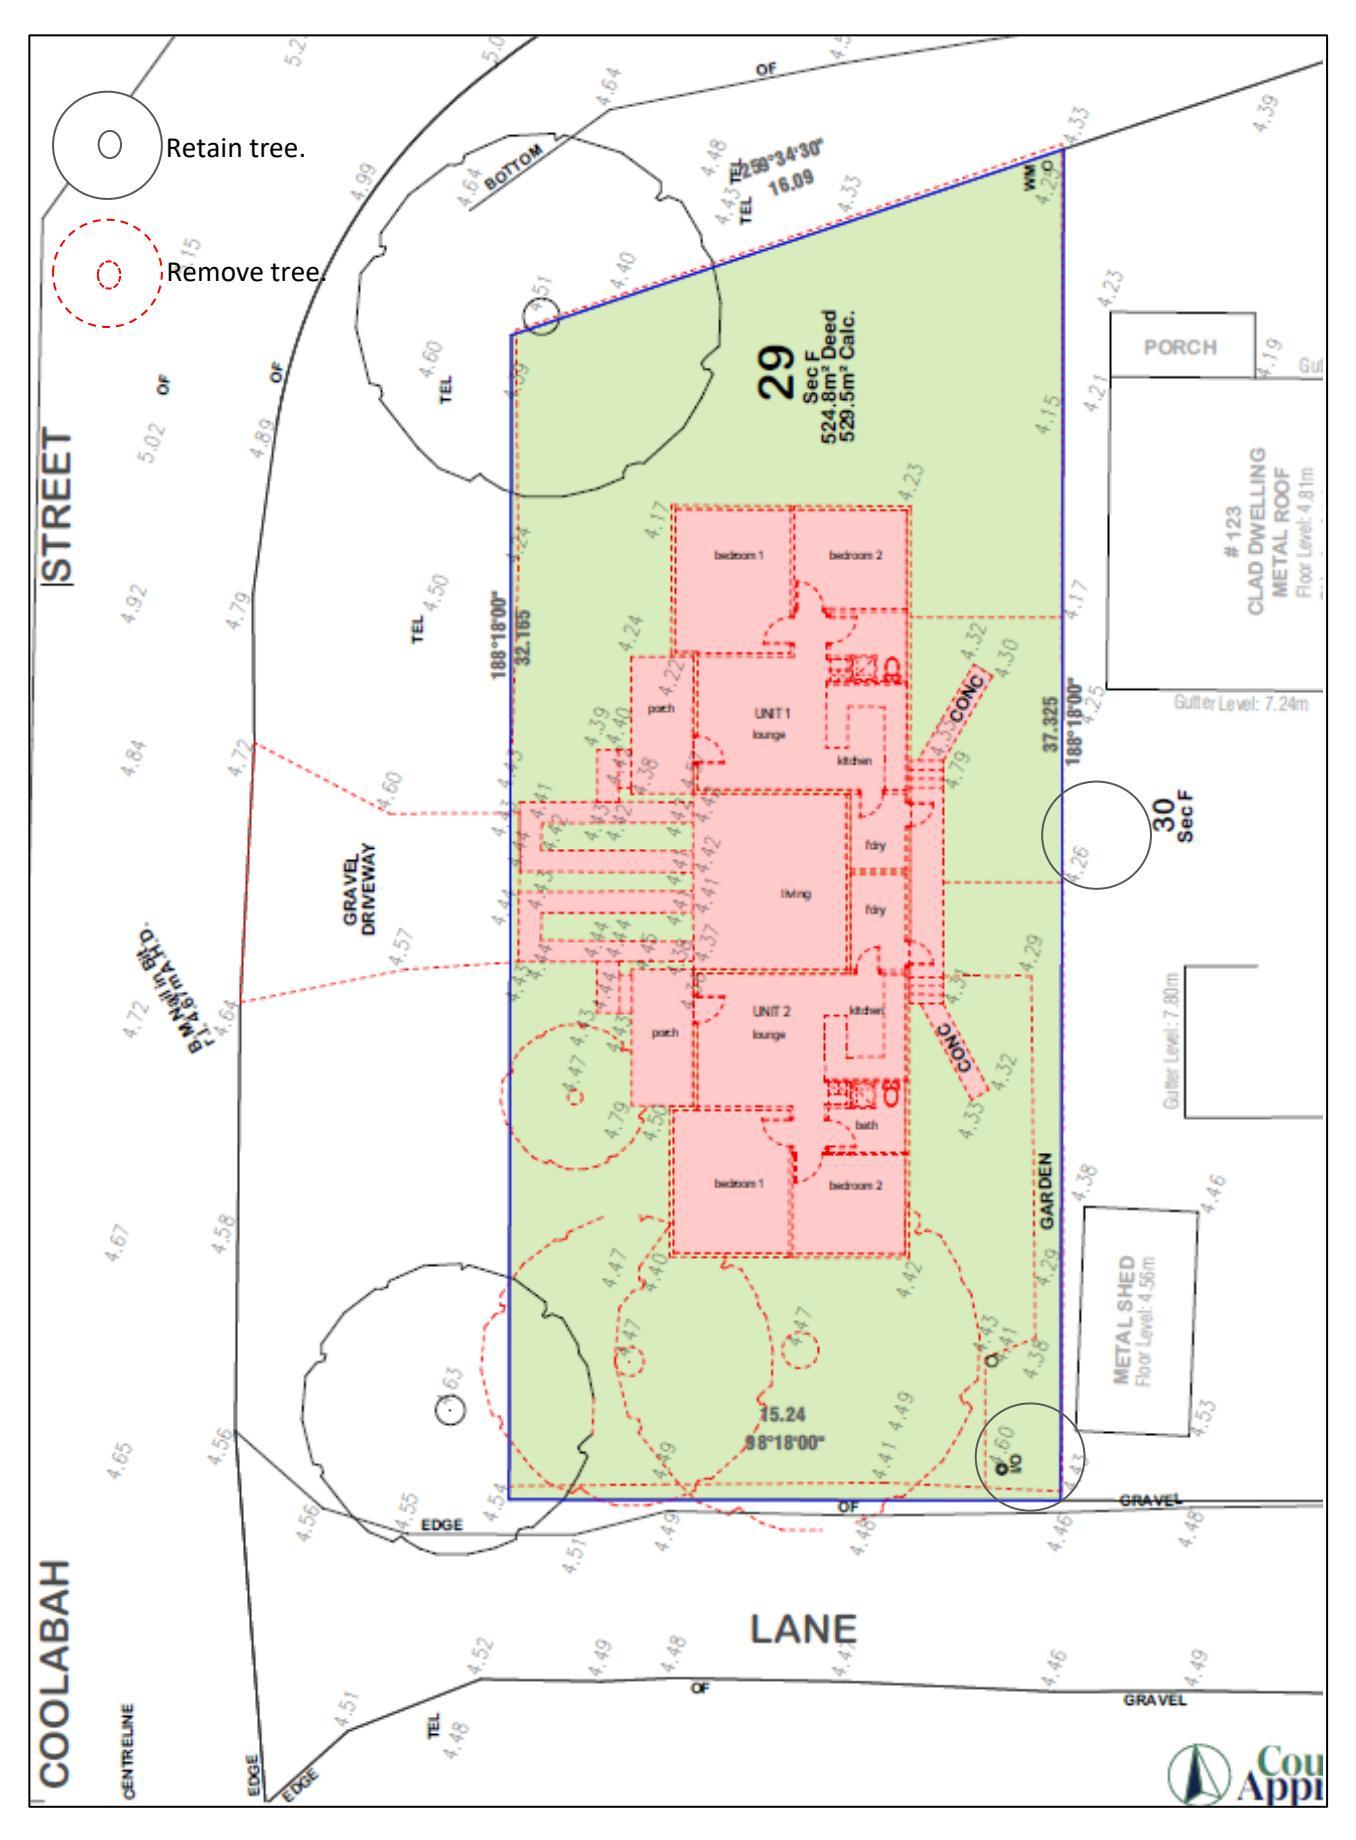
12.4 Proposed Site Plan (extract) + Tree protection

All protective measures are to be installed prior to the commencement of demolition works in accordance with the tree protection plan at appendix 12.3 and the provisions of AS4970 detailed at appendix 12.4.A.
