Arborist Report

Client: Bayside Central Pty Ltd

Address: 40 Bogan Road,

BOOKER BAY N.S.W 2257

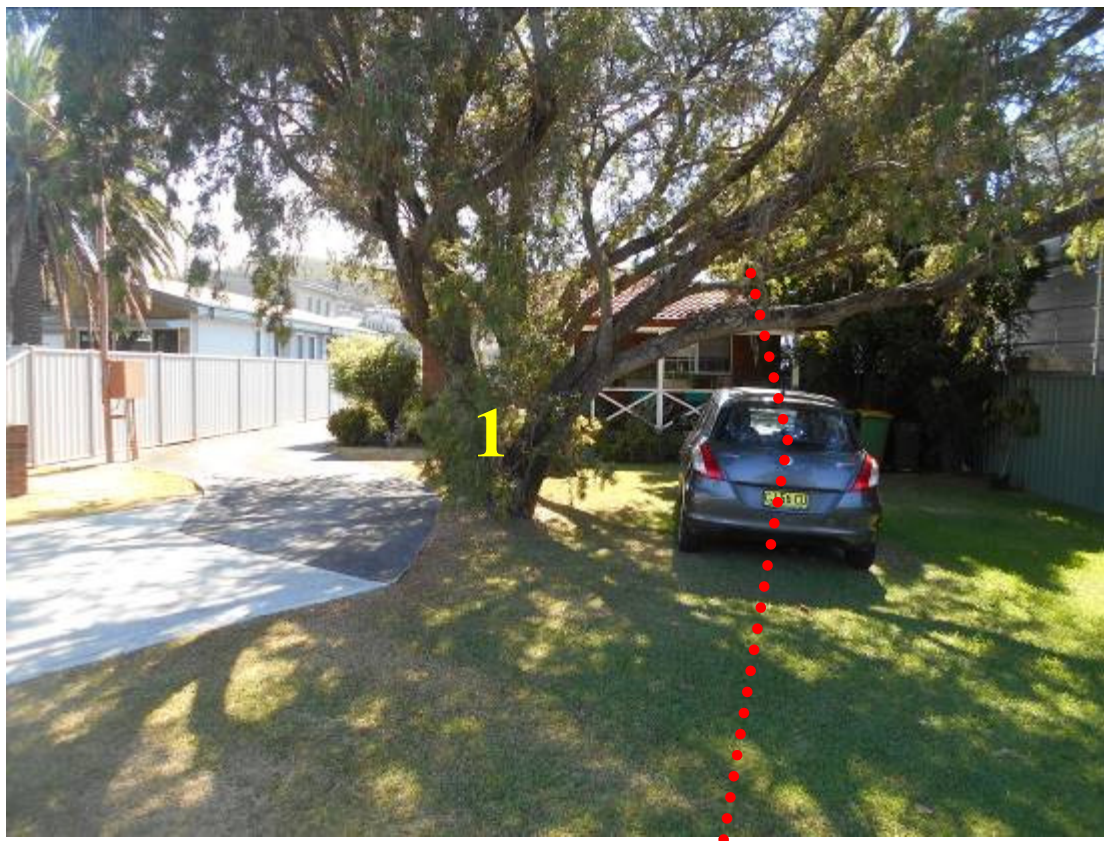
All trees require a S.R.Z and a T.P.Z with Australian Standards 4970- 2009 being used as a guideline. Tree 1 has been given an SRZ and TPZ of 2.83 & 6.24 metres in accordance with Australian Standards 4970 - 2009. Tree 1 is located closest to the nature strip as outlined in Figure 3. Tree 1 is located 2.1 metres to the proposed driveway and 3.2 metres to the proposed veranda. Tree 1 is located 4.4 metres to the proposed development (Unit 1). AS 4970 – 2009 indicates that the TPZ radius is taken from the centre of the trunk. This leaves a spatial separation of 2.45 metres from the centre of the trunk to the proposed driveway. This leaves a spatial separation of 3.55 metres from the centre of the trunk to the proposed veranda. This leaves a spatial separation of 4.75 metres from the centre of the trunk to the proposed development (Unit 1). The loss associated with the veranda is calculated at 8.19%. The loss associated with the driveway is calculated at 21.39%. The loss associated with the building (Unit 1) has been calculated at 3.48%. The overall loss of TPZ has been calculated at 33.06% that doesn't comply with AS 4970 – 2009. Placing the driveway at existing ground levels within the TPZ using 'stoneset' or similar would see no net loss of TPZ. The deck is to be constructed using bearers and joists or similar method of construction whilst retaining existing soil levels. The net loss of TPZ could be reduced to an estimated 1.5%. The overall loss would be reduced to 4.98% that complies with AS 4970 – 2009. This is based on the proviso that no civil or earthworks occur between the trunk and the development including the section of TPZ inside the proposed driveway. Tree 1 is earmarked for retention.

Figure 3 – showing the location of Tree 1. A driveway design such as ‘stoneset’ at existing ground levels will enable the retention of Tree 1.

- It is recommended that Tree 1 (1 in total) be retained and incorporated into the development. It is recommended that the existing concrete driveway be removed by non-mechanised methods inside the TPZ. This includes removing 1 metre sections of concrete by diamond saw or similar. Any root plate exposed on this side of the TPZ is to be retained and grass or mulch is to be used in this section of the TPZ. Once the existing driveway is removed within the TPZ will require grass or mulch to be laid within three (3) working days. This will avoid the root plate from drying out or being damaged by workmen. It is recommended that the proposed driveway be constructed using ‘stoneset’, ‘grasscrete’ or similar method of construction. The soil levels are to be retained within the section of driveway within the TPZ. No strip footings are allowed to construct the proposed driveway inside the TPZ.

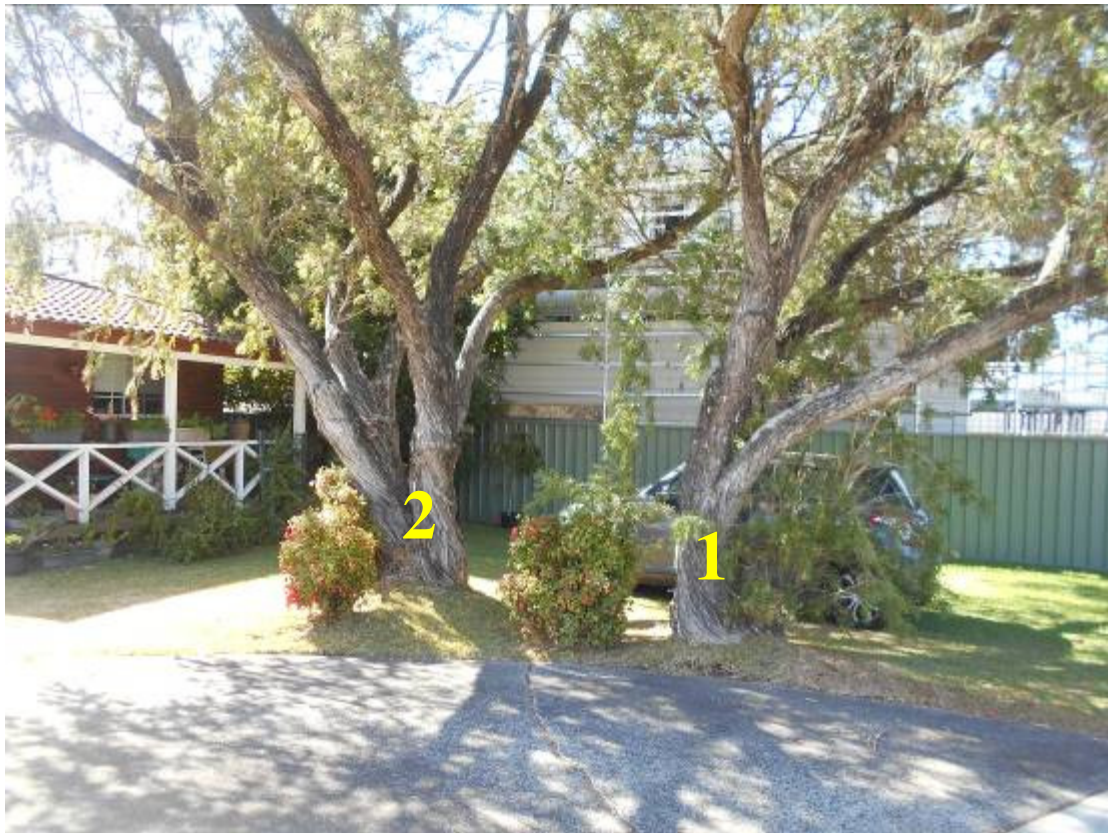
Tree 2 has been given an SRZ and TPZ of 2.81 & 7.68 metres in accordance with Australian Standards 4970 - 2009. Tree 2 will be located 0.9 metres to the proposed veranda and 2 metres to the development (Unit 1). AS 4970 – 2009 indicates that the TPZ radius is taken from the centre of the trunk. This leaves a spatial separation of 2.34 metres from the centre of the trunk to the proposed development. I have only allowed for a loss of 1.5% associated with the deck as bearers and joists or similar is to be used to allow the retention of Tree 1. I have also applied this loss for Tree 2. The overall loss of TPZ associated with the development has been calculated at 30.93% that doesn't comply with AS 4970 – 2009. This would increase to 32.43% taking into consideration both the development and the deck. Tree 2 is earmarked for removal before commencement of building works on site.

Figure 4 – showing the location of Trees 1 & 2. The proposed development will be considerably closer to the trunk of Tree 2. The existing driveway will need to be removed in small sections within the TPZ. Any and all root plate is to be retained within the TPZ that is earmarked for open space

- It is recommended that Trees 2 & 3 (2 in total) be removed immediately (before commencement of building works) by a qualified arborist (minimum certificate 2 in arboriculture). It is recommended that professional indemnity and public liability insurances be current and sighted before commencement of works begin. The level of cover has to be one in agreement between Bayside Central Pty Ltd and the arborist.

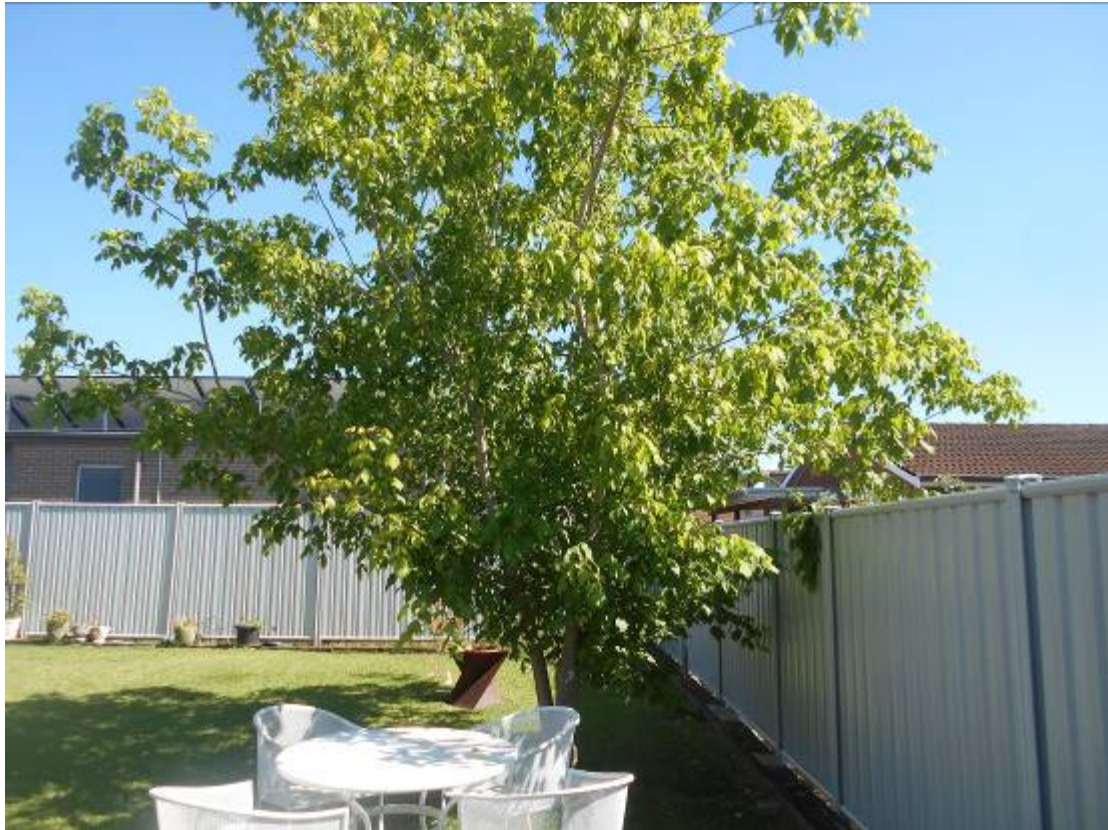
Tree 3 has been given an SRZ and TPZ of 1.77 & 2.58 metres in accordance with Australian Standards 4970 - 2009. This species has been identified as a weed species in NSW. This species has low landscape significance and is earmarked for removal. This species can reach a height of 15 metres (minimum) when fully mature. This species can have extensive root plates that far exceed the dip line. This species will be located 2.5 metres to the proposed development. The current distance complies with AS 4970 – 2009. This species will outgrow its available growing space when fully mature. Tree 3 is earmarked for removal before commencement of building works on site.

Figure 5 – showing the location of Tree 3 in the backyard of the subject property/

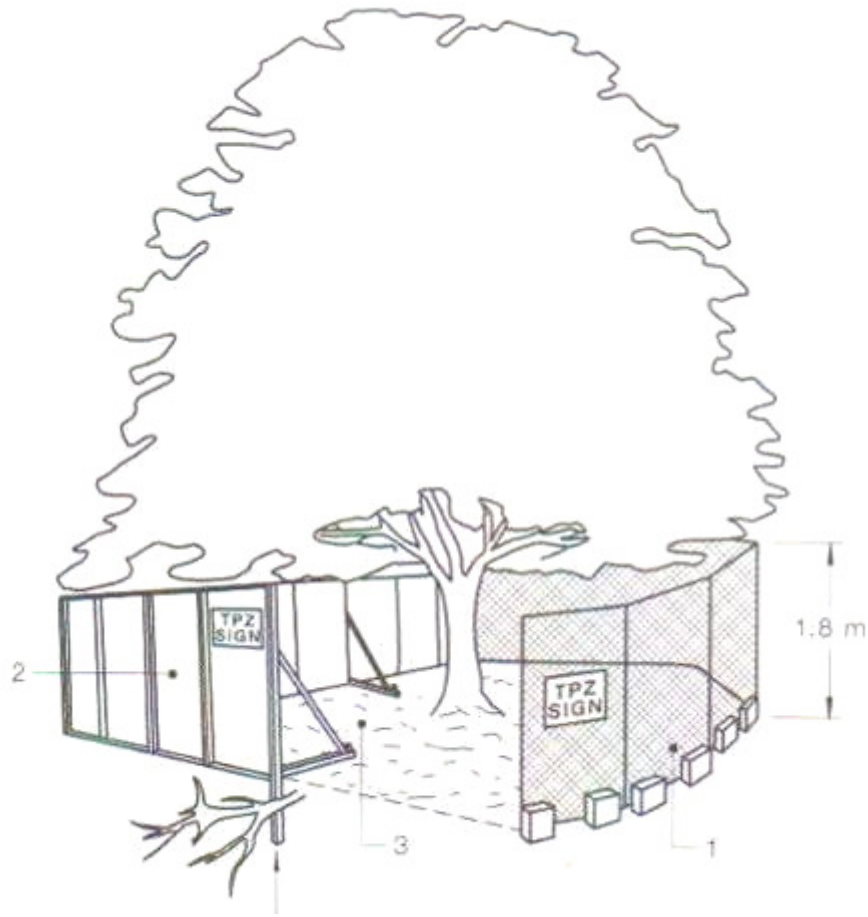
- Figure 6 – showing the proposed fencing that is to be put in place before the commencement of building works on site (Tree 1 only).
Source: Australian Standards 4970 - 2009

- It is recommended that protection measures be put in place that aid in the preservation of Tree 1 (1 in total). It is recommended that 1.8 metre inter locking chain wire fencing be installed before commencement of building works on site as indicated in Figure 6. Protection fencing is to be installed to the edge of the proposed driveway within the TPZ. The fencing is to extend to the proposed veranda and continue to the edge of the TPZ to the northern quadrant. Fencing to the western side will be located at the boundary and connect with the other two sides as indicated in Figure 7. Protection fencing is to be installed before commencement of all civil & building works and remain in place until the release of the occupation certificate.
