Limited Geotechnical Investigation

Lot A DP 339787 166 Booker Bay Road, Booker Bay

22 December 2022 5QS Ref: 222093

Re: Limited Geotechnical Investigation Proposed Residential Development – Lot A DP 339787 166 Booker Bay Road, Booker Bay

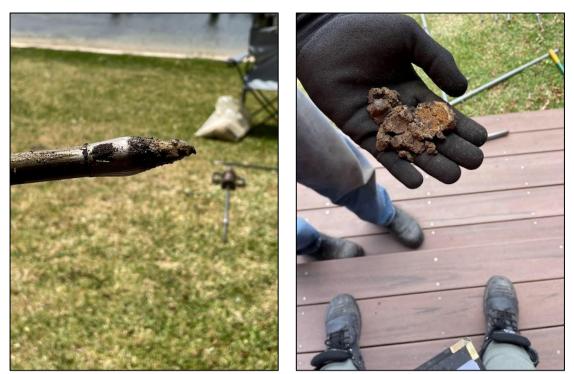
Photographs P6 and P7 – Detail of DCP probe tip on removal, and test spoil taken at test location BH1, respectively

Photographs of the test results can be seen below in photos P6 to P15.

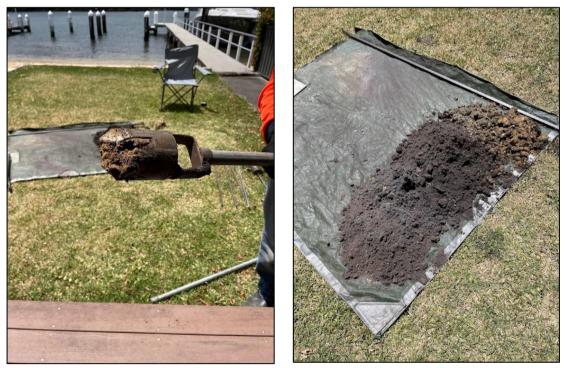
Photographs P8 and P9 – Detail of spoil in Jarrett auger and spoil layers from test location BH1, respectively

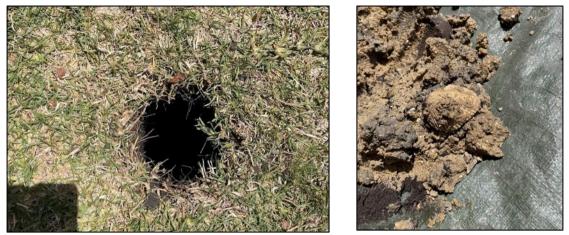
Photographs P10 and P11 – Detail of borehole and spoil, taken at test location BH3

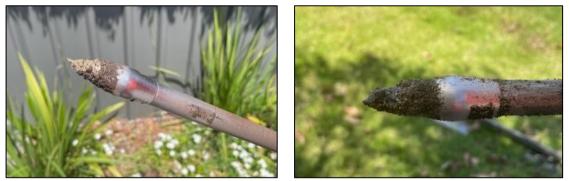
Photographs P12 and P13 – Detail of probe tip on removal, taken at test locations BH3 and BH2, respectively

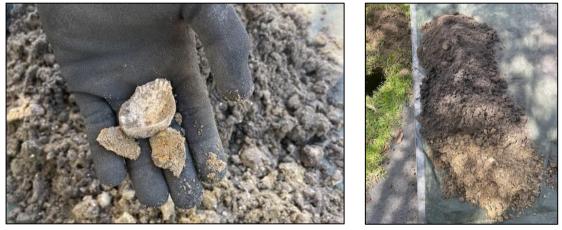
Photographs P14 and P15 – Detail of samples and spoil taken at test location BH2, respectively
