## Dilapidation Inspection Report

Inspection Date: Thu, 9 Apr 2026

Property Address: 30 Beach St, Ettalong Beach NSW 2257,  
Australia

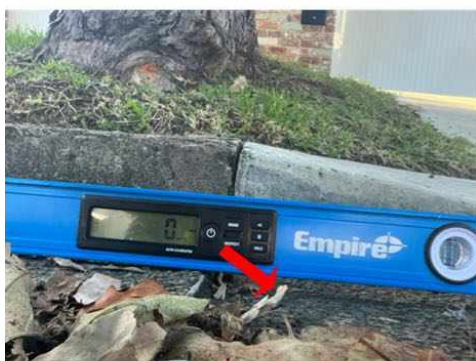
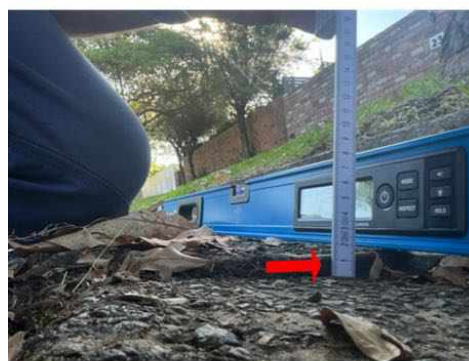
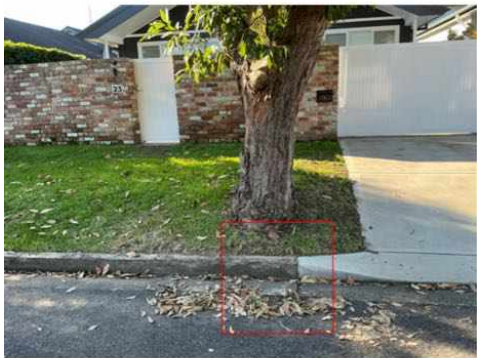
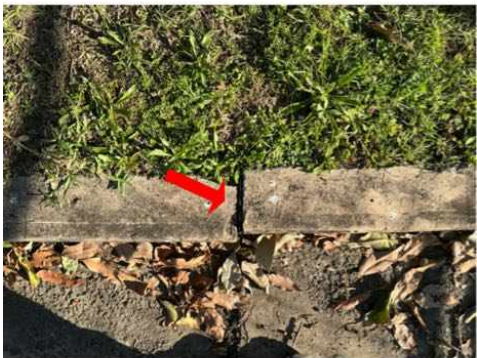
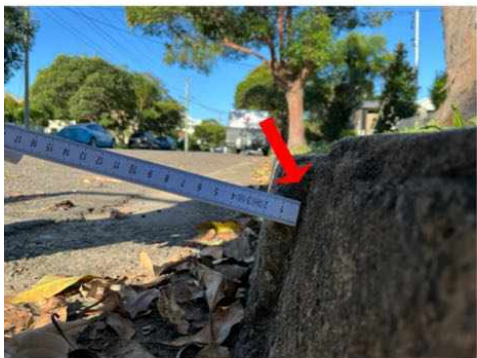
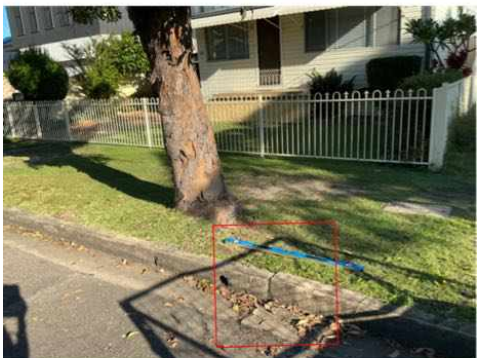
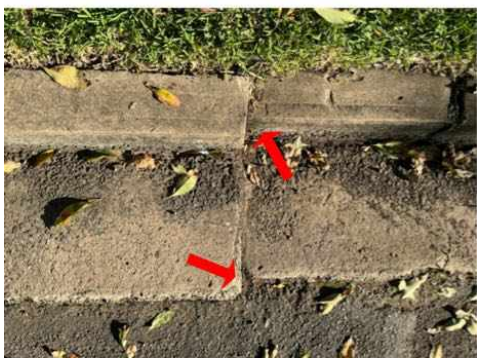
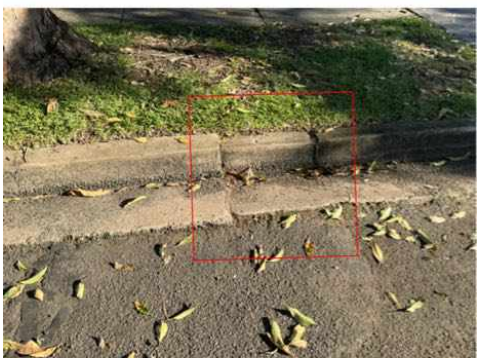
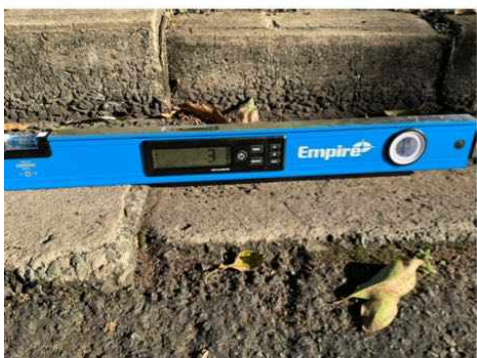
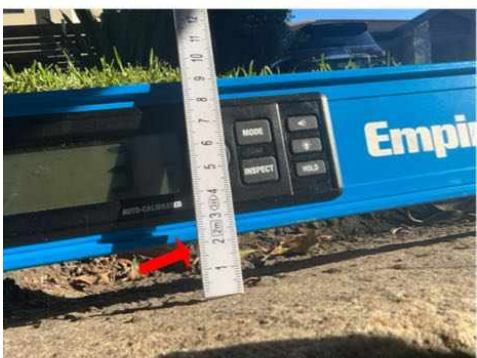
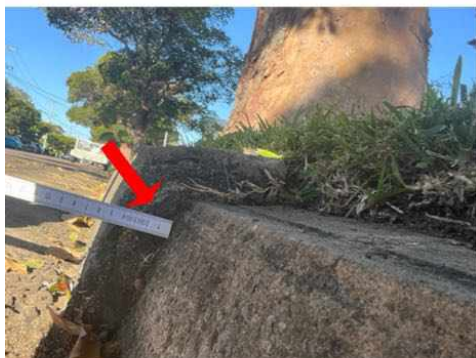
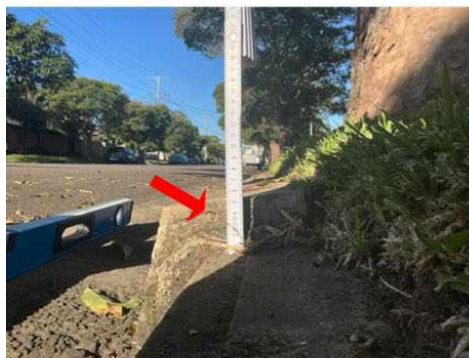
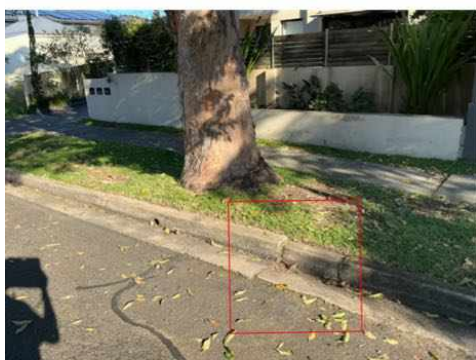
#### Defects 3.01

Building: Main Building  
 Location: House Number 23, 28 & 32  
 Finding: Kerbside Concrete - Damaged & Subsided (Dilapidation)  
 Information: At the time of inspection, sections of the curbside concrete kerb were observed to be cracked, chipped, and locally subsided. Minor vertical displacement was noted between adjoining concrete sections, consistent with settlement and general wear and tear. Surface cracking and edge deterioration were also evident along portions of the kerb line. Based on visual assessment, the recorded variation appears minor at this stage and does not currently present a significant structural concern.

The affected areas should be monitored throughout the construction period for any signs of additional movement, cracking, widening of joints, or further settlement.

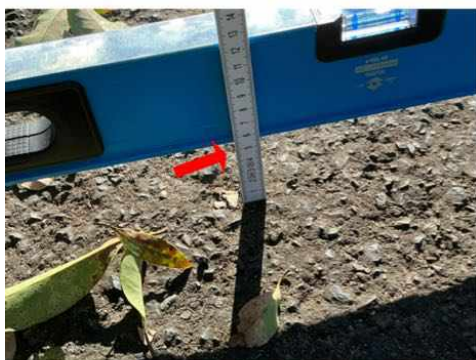
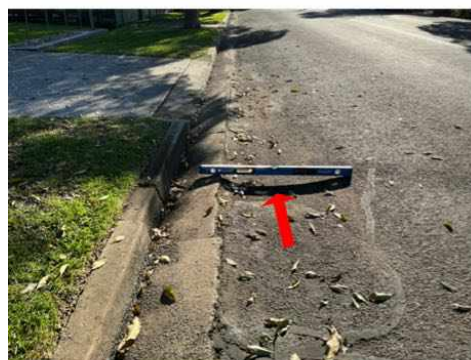
### Defects 3.02

| Information: | At the time of inspection, sections of the roadway adjacent to the kerb were observed to be locally subsided, with uneven surface levels noted in the affected area. The subsidence appears to have resulted in minor depressions and variation in surface levels, as recorded in the accompanying images. |

This condition is documented as part of the existing state of the roadway for dilapidation purposes. The client is advised to monitor the area during and after construction works for any signs of further settlement, deformation, or deterioration.

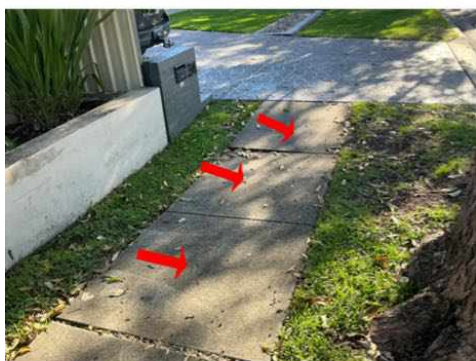
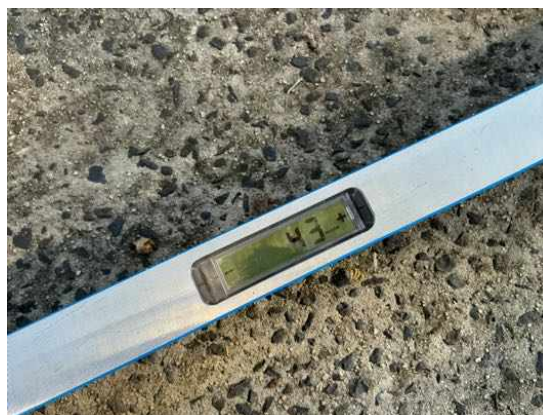
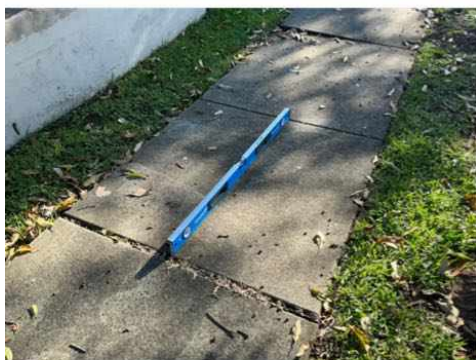
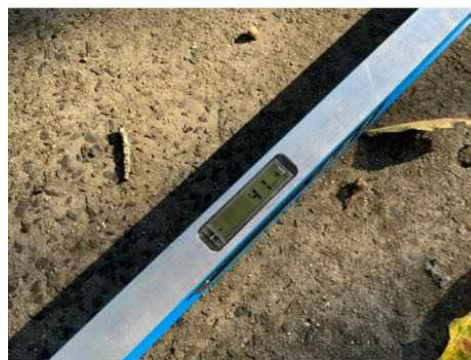
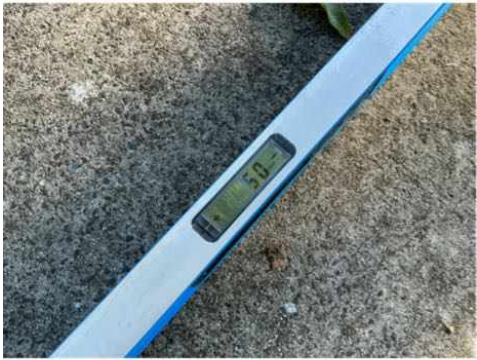
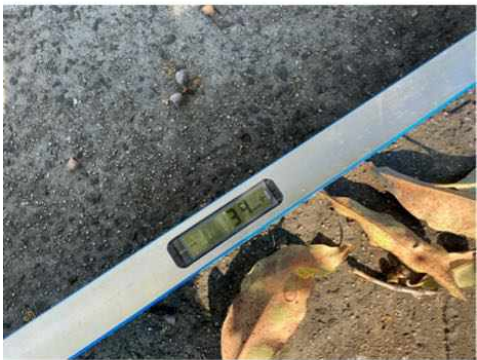
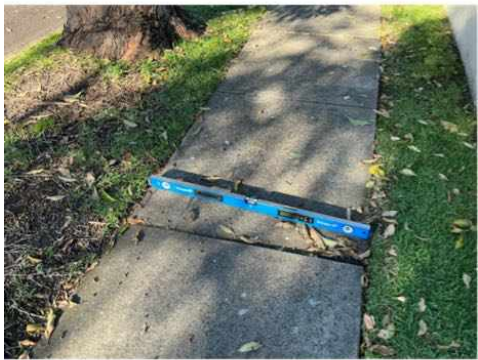
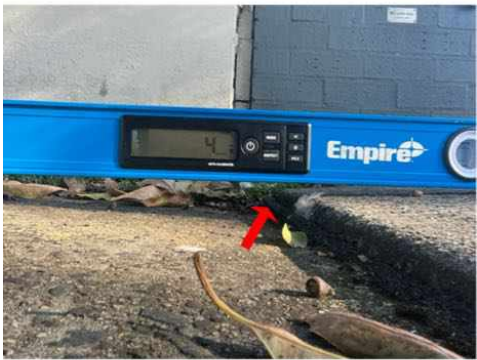
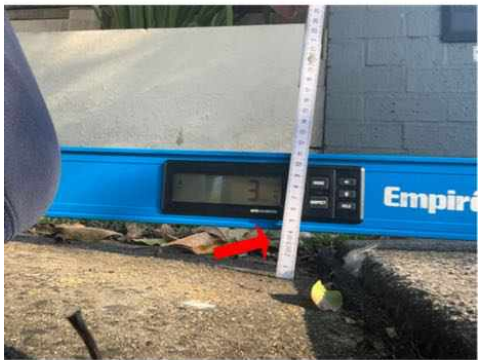
### Defects 3.03

| Finding: | Subsided Footpath (Dilapidation) |
| Information: | At the time of inspection, subsidence was noted in sections of the external footpath located at the front area of the property. A digital level was used to confirm slope variations, which recorded measurable deviations from level (examples shown in accompanying photos). The subsidence may pose a potential trip hazard and can also lead to water pooling or uneven surface wear over time. This condition should be monitored during construction activities, particularly if heavy machinery or increased foot traffic is expected, to ensure no further deterioration or safety risks occur. |

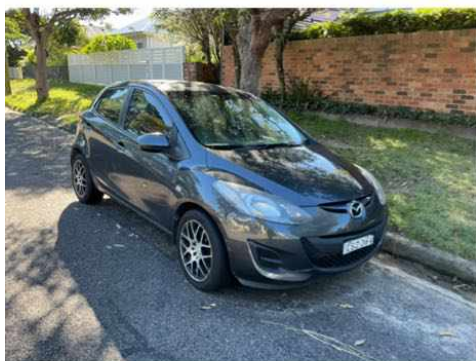
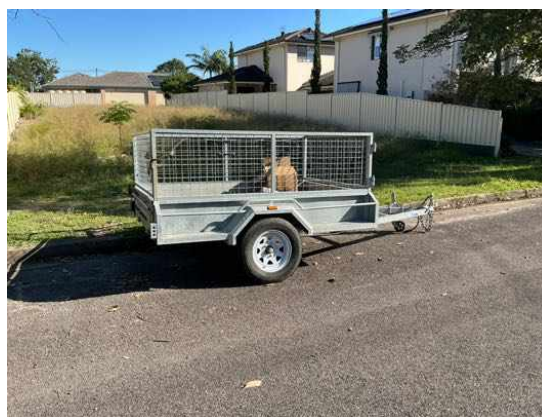
| Finding: | Additional Photos - Obstructions and Limitations |
| Information: | These photographs are an indication of the obstructions and limitations which impeded full inspection of the property at the time of inspection. These obstructions can hide an array of defects and should be removed to allow full inspection to be carried out. A re-inspection is recommended once the areas are made accessible. |

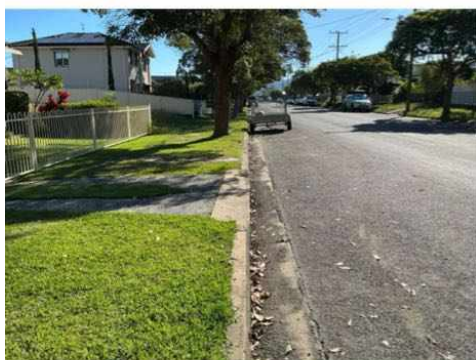
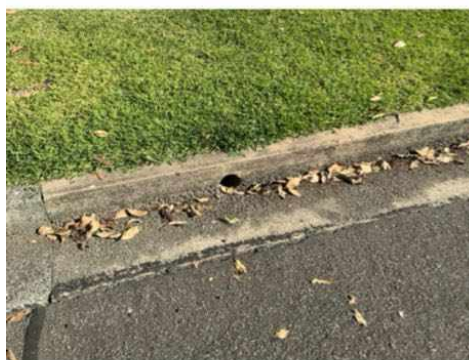
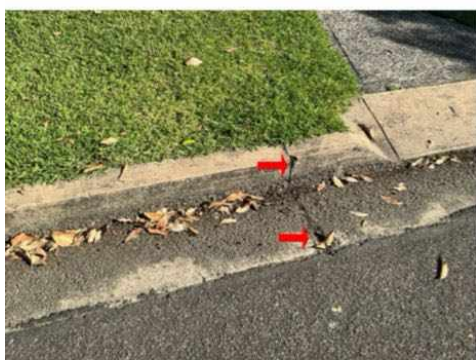
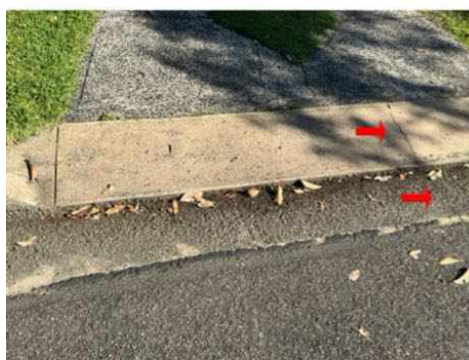
| Information: | Cracking and deterioration of the concrete slab in this area were observed during the inspection. These types of cracks are typically consistent with general wear, dilapidation, and the natural ageing of the structure. If left unaddressed, the deterioration may progress over time, potentially leading to further damage. |

At the time of the inspection, the cracks exhibited varying sizes and widths, indicating differing stages of development. It is recommended that regular monitoring be undertaken to assess any progression of the cracking and to identify potential future maintenance requirements.

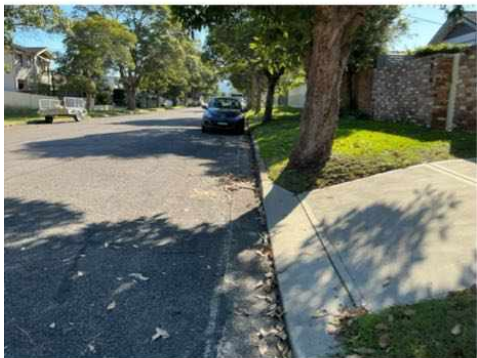
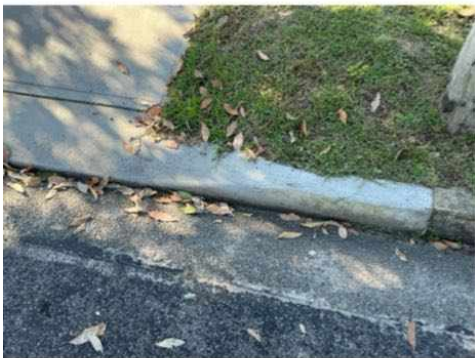
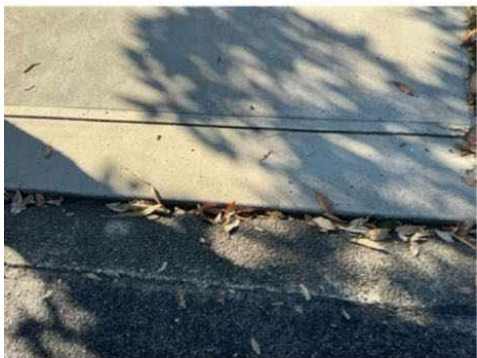
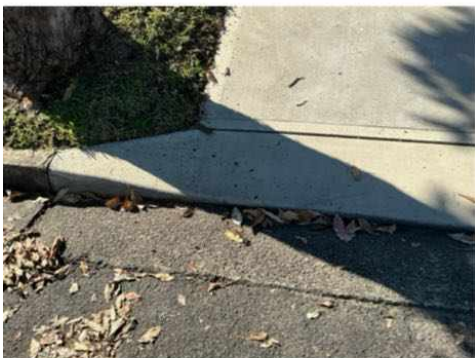
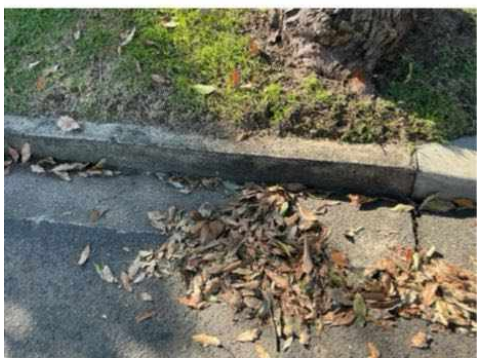
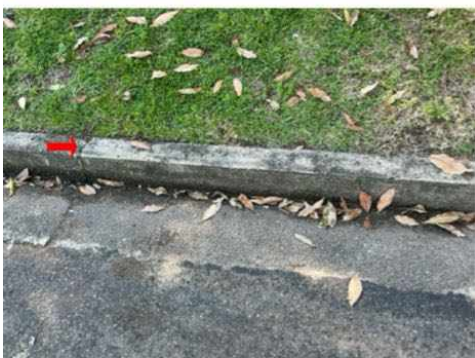
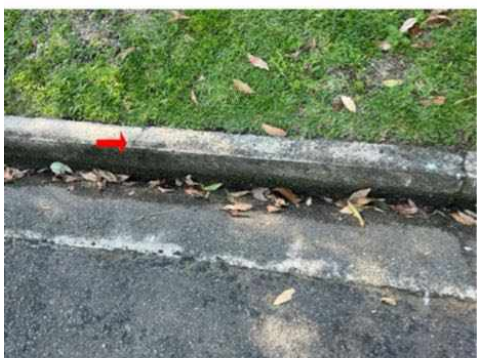
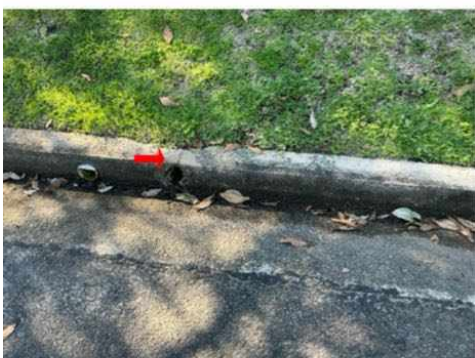
| Information: | Cracking and deterioration of the concrete slab in this area were observed during the inspection. These types of cracks are typically consistent with general wear, dilapidation, and the natural ageing of the structure. If left unaddressed, the deterioration may progress over time, potentially leading to further damage. |

At the time of the inspection, the cracks exhibited varying sizes and widths, indicating differing stages of development. It is recommended that regular monitoring be undertaken to assess any progression of the cracking and to identify potential future maintenance requirements.

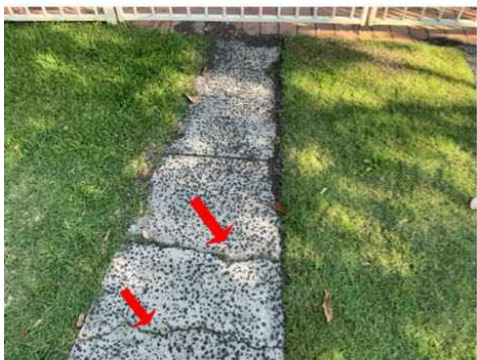
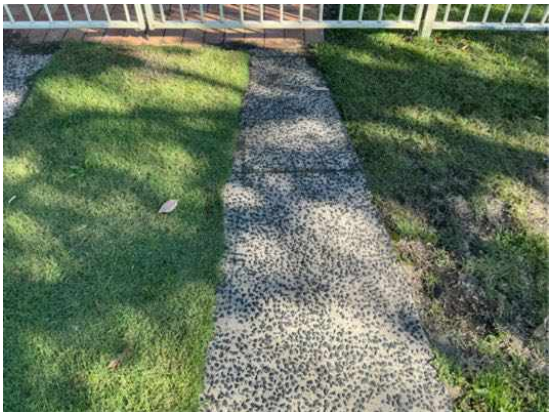
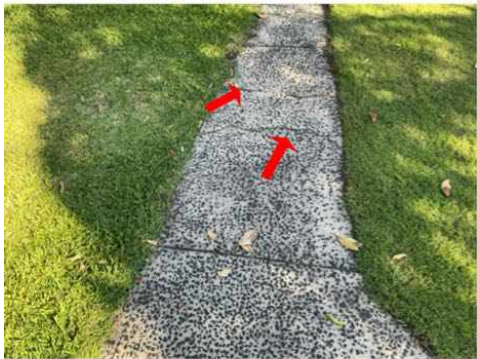
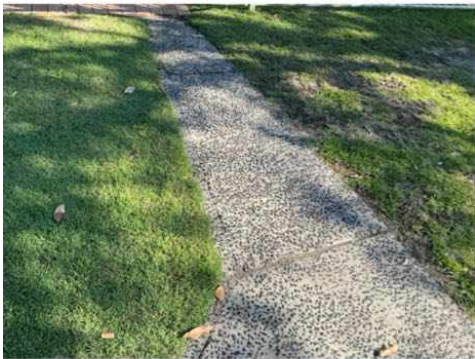
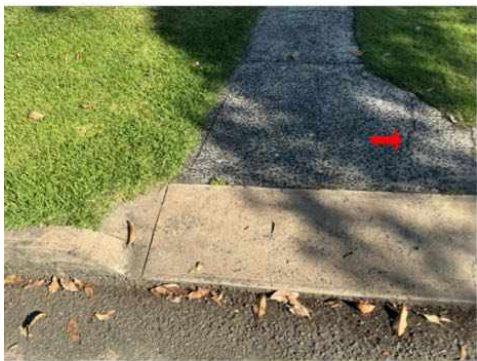
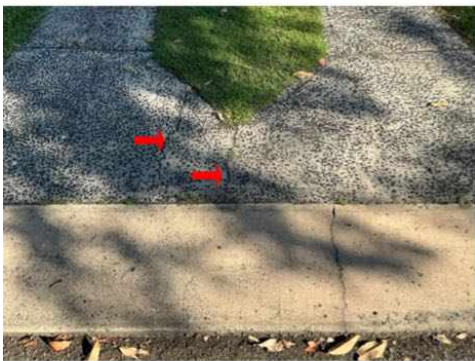
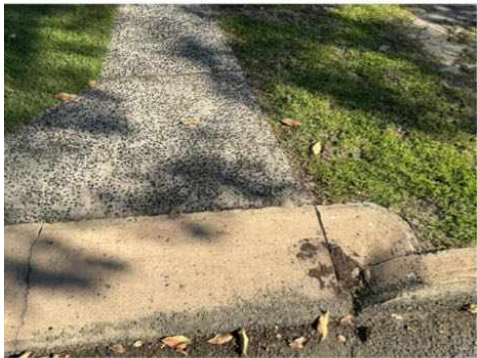
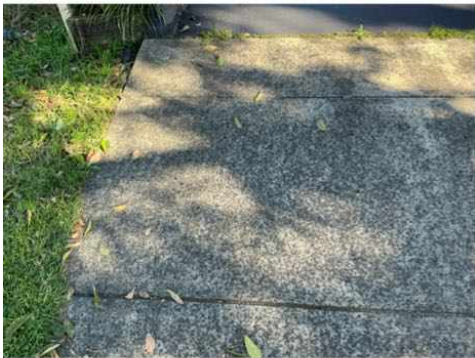
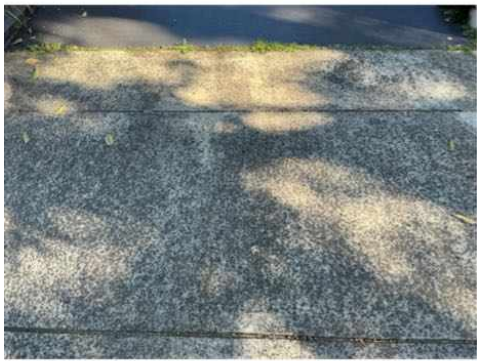
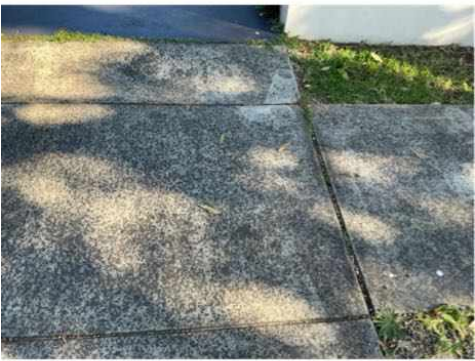
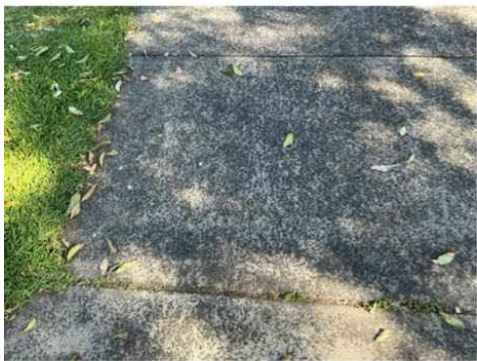
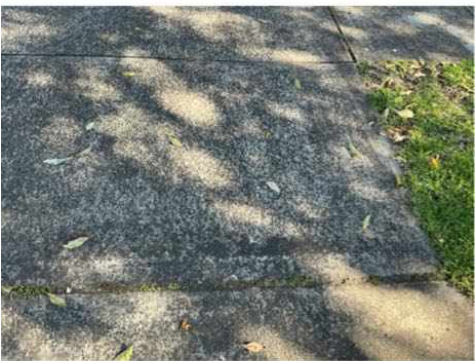
| Information: | Cracking and deterioration of the concrete slab in this area were observed during the inspection. These types of cracks are typically consistent with general wear, dilapidation, and the natural ageing of the structure. If left unaddressed, the deterioration may progress over time, potentially leading to further damage. |

At the time of the inspection, the cracks exhibited varying sizes and widths, indicating differing stages of development. It is recommended that regular monitoring be undertaken to assess any progression of the cracking and to identify potential future maintenance requirements.

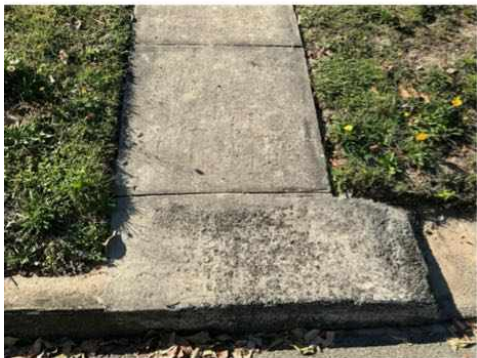
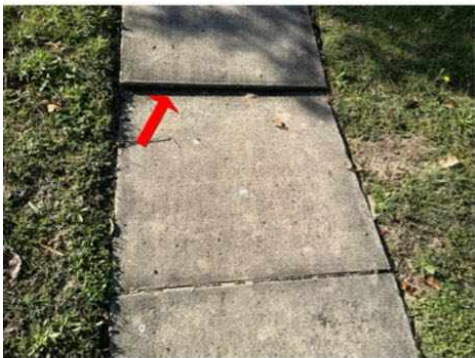
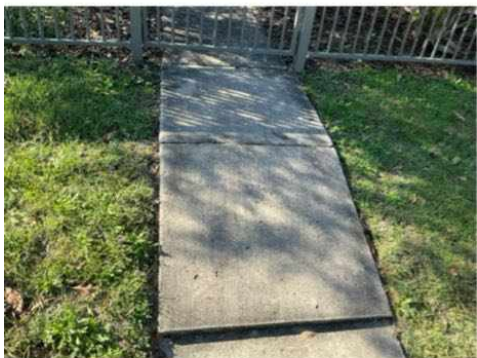
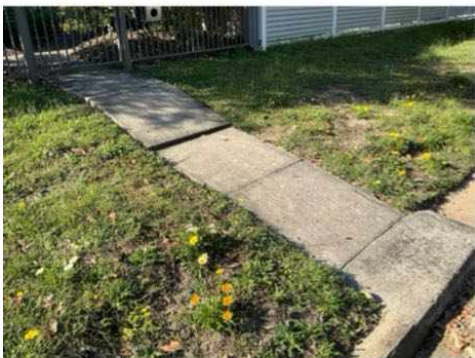
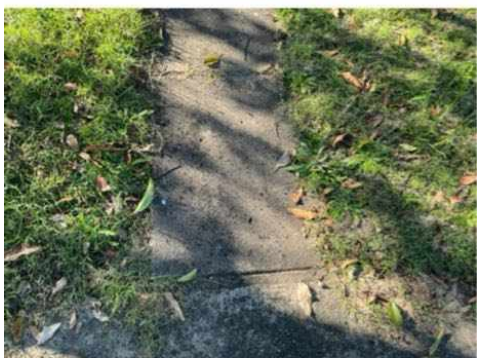
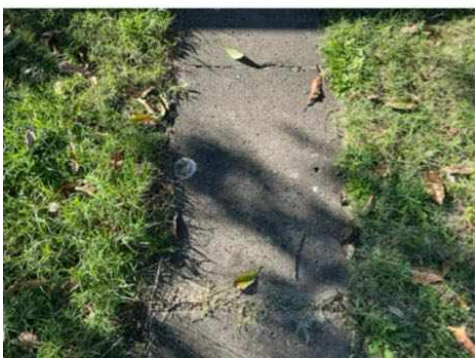
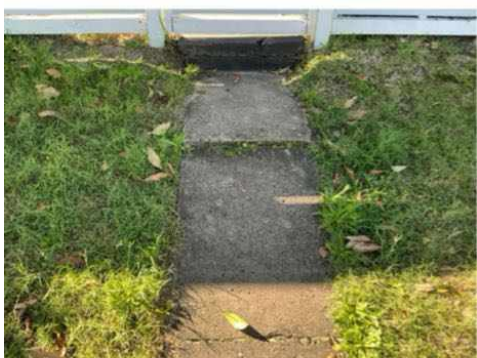
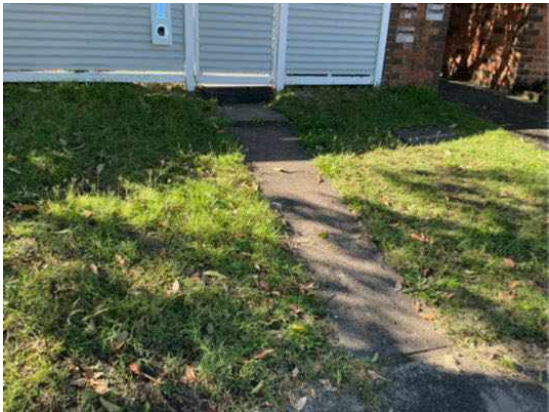
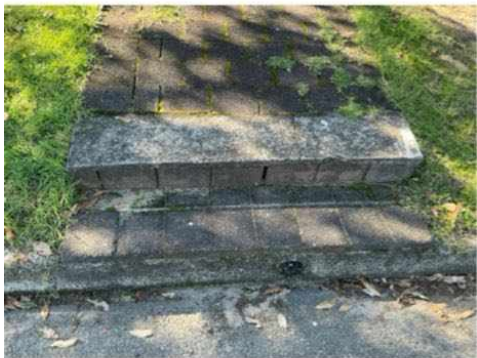
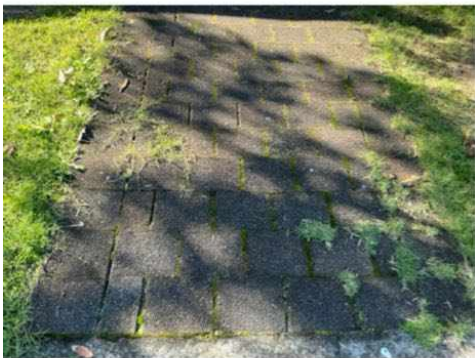
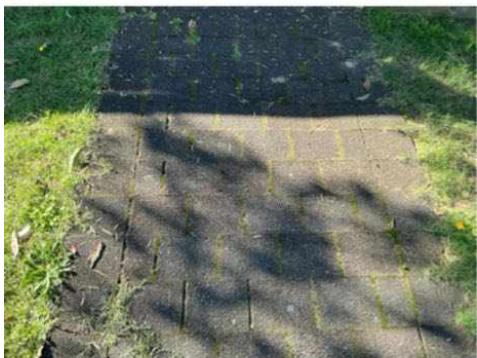
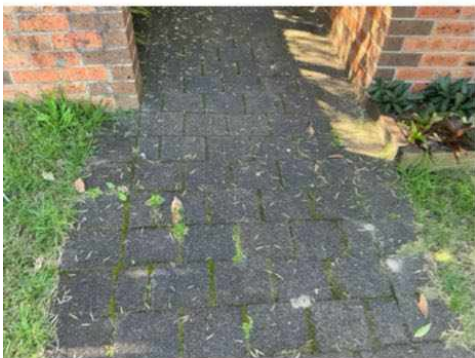
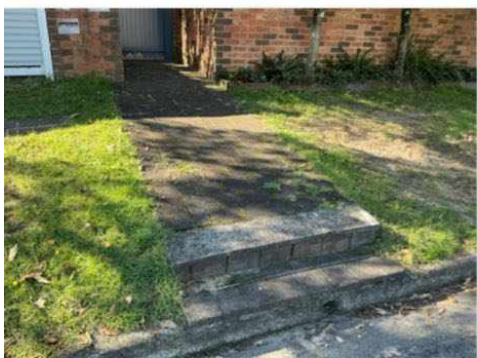
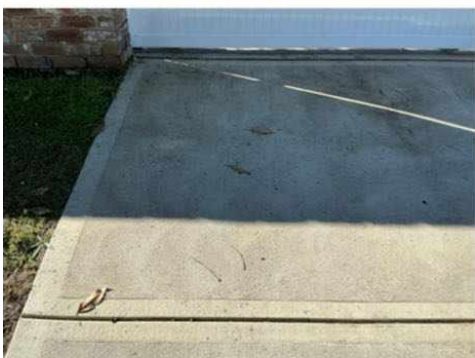
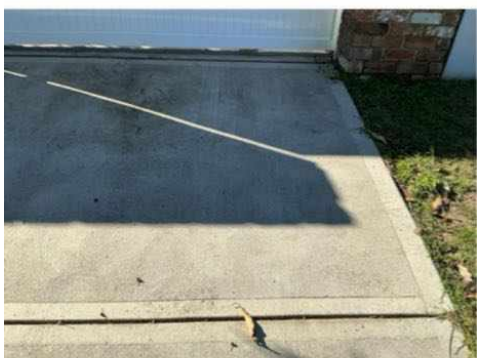
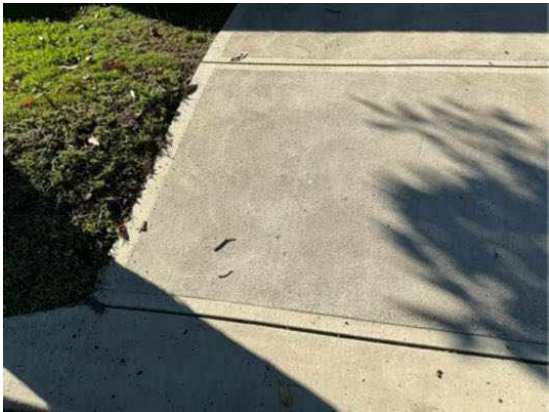
| Information: | Cracking and deterioration of the concrete slab in this area were observed during the inspection. These types of cracks are typically consistent with general wear, dilapidation, and the natural ageing of the structure. If left unaddressed, the deterioration may progress over time, potentially leading to further damage. |

At the time of the inspection, the cracks exhibited varying sizes and widths, indicating differing stages of development. It is recommended that regular monitoring be undertaken to assess any progression of the cracking and to identify potential future maintenance requirements.

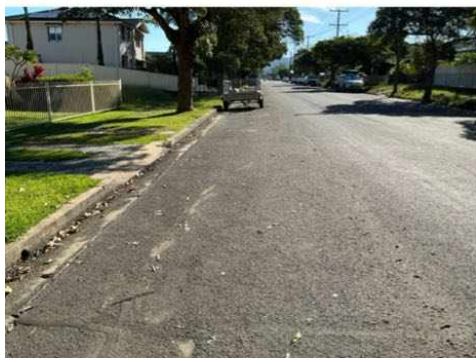
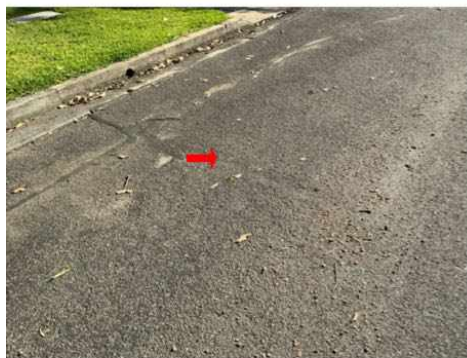
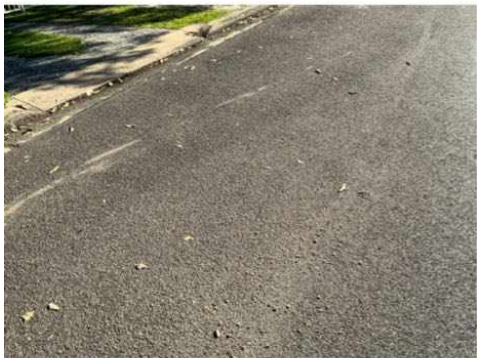
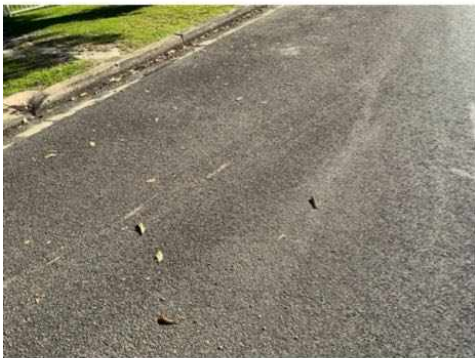
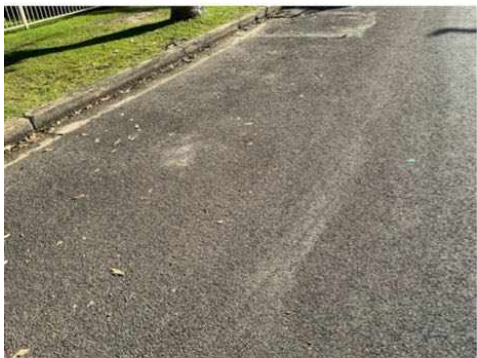
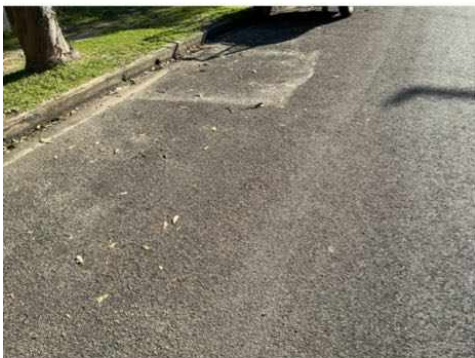
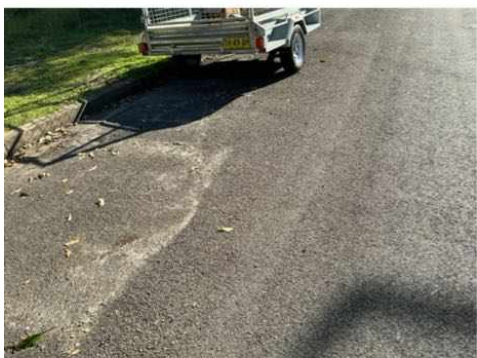
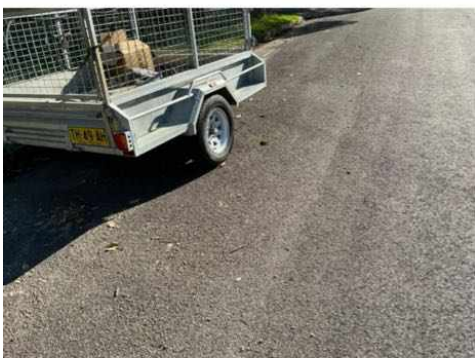
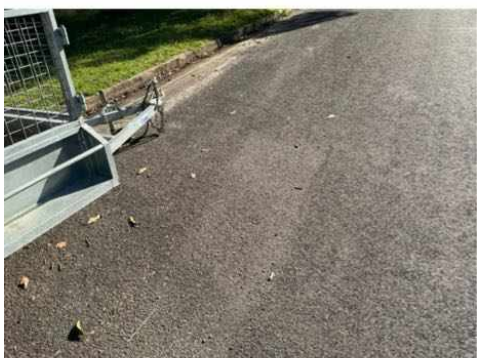
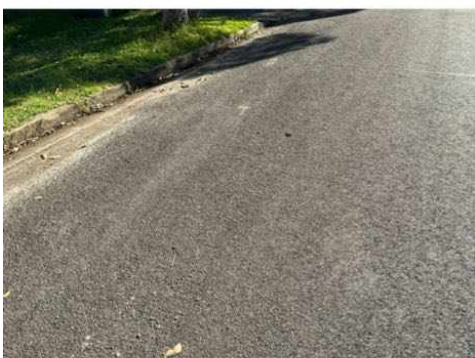
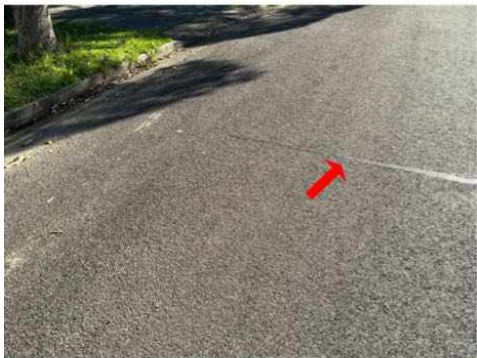
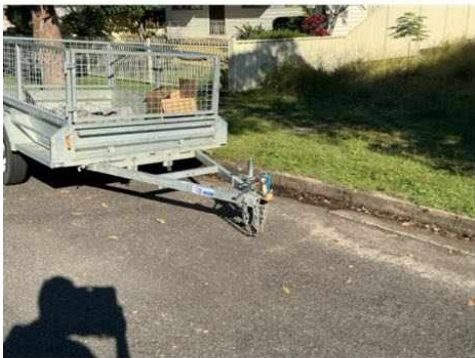
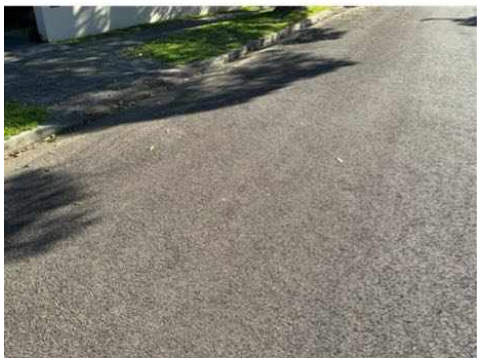
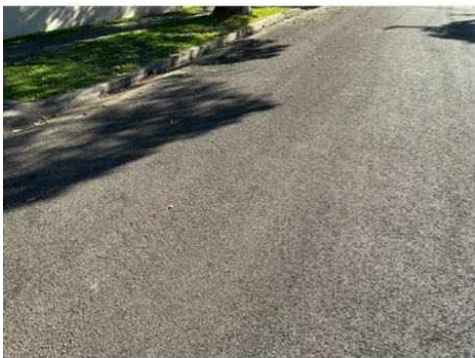
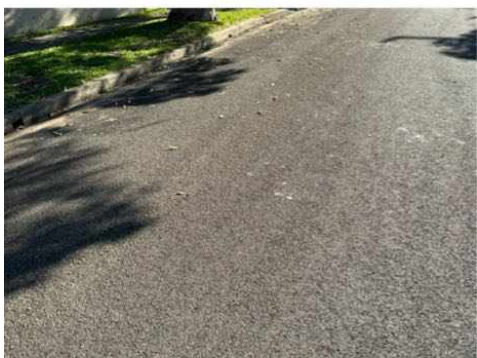
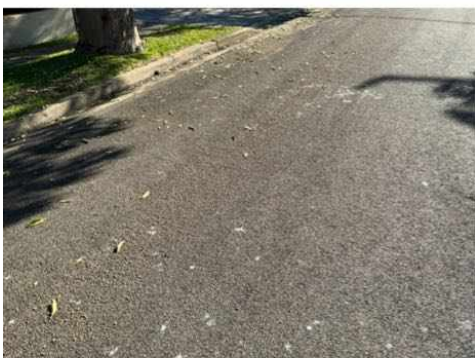
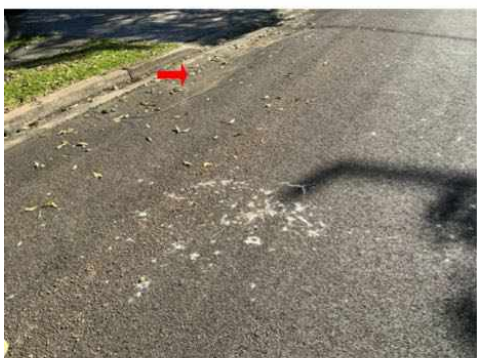
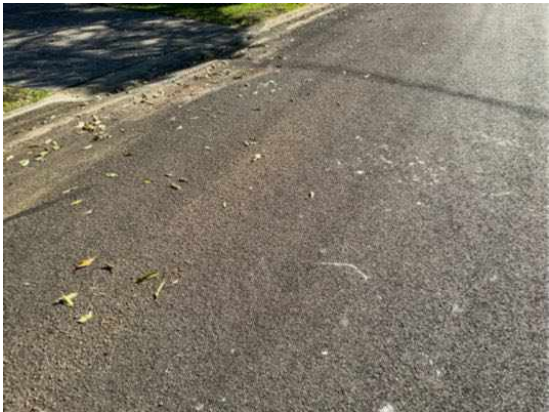
Building: Main Building  
Location: Road Carriageway or Roadway Left Side  
Finding: Roadway Asphalt (Dilapidation)  
Information: At the front of the property there were clear signs of minor cracking and 'spiderwebbing' to the asphalt in the area at the time of inspection.

This type of cracking is often consistent with general dilapidation of the area, and may continue to develop if left unmaintained.

At the time of the inspection, the cracking in this area is in varying sizes and widths as noted in these images. Frequent monitoring should be carried out to identify any further damage.

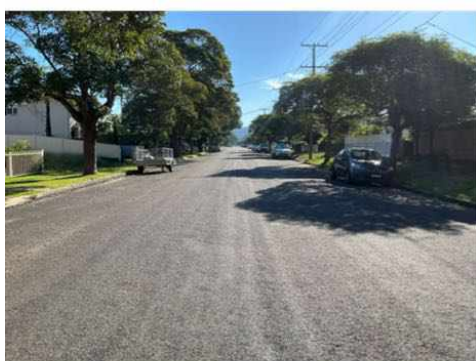
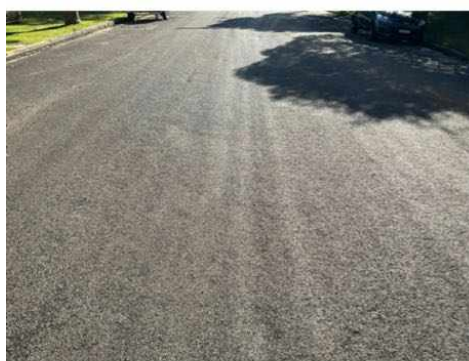
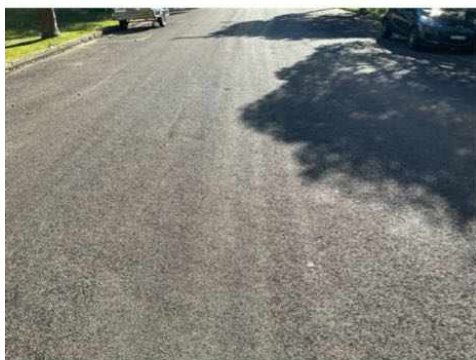
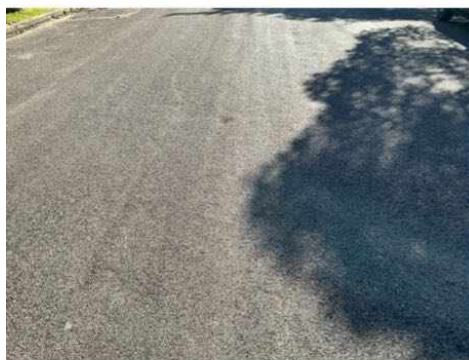
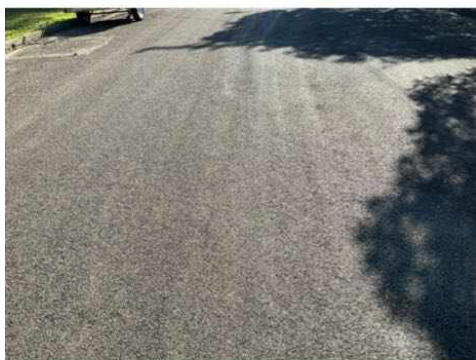
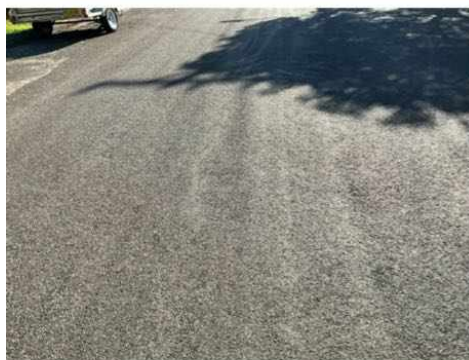
Building: Main Building  
Location: Road Carriageway or Roadway Middle  
Finding: Roadway Asphalt (Dilapidation)  
Information: At the front of the property there were clear signs of minor cracking and 'spiderwebbing' to the asphalt in the area at the time of inspection.

This type of cracking is often consistent with general dilapidation of the area, and may continue to develop if left unmaintained.

At the time of the inspection, the cracking in this area is in varying sizes and widths as noted in these images. Frequent monitoring should be carried out to identify any further damage.

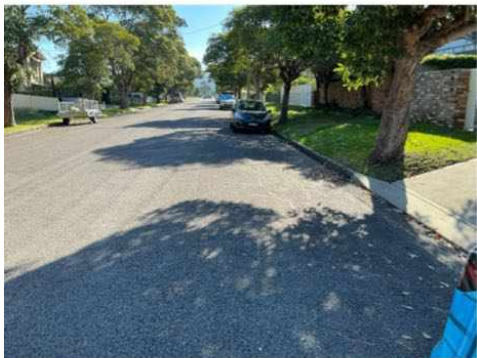
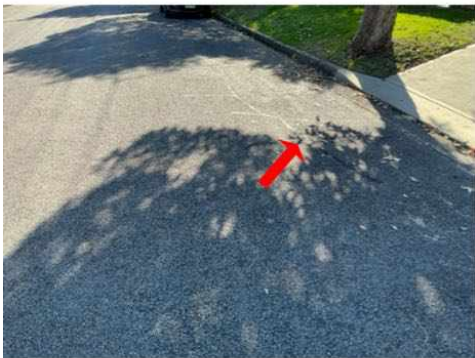
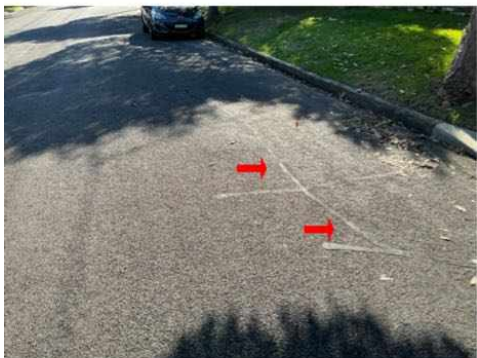
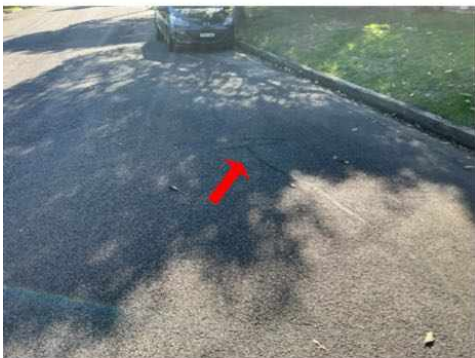
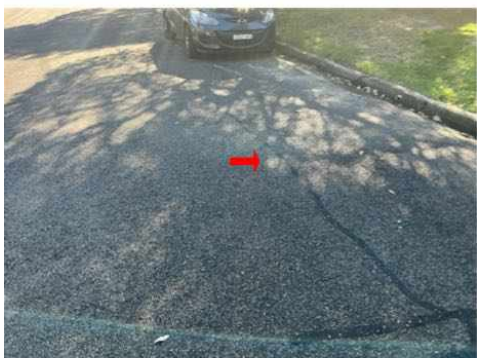
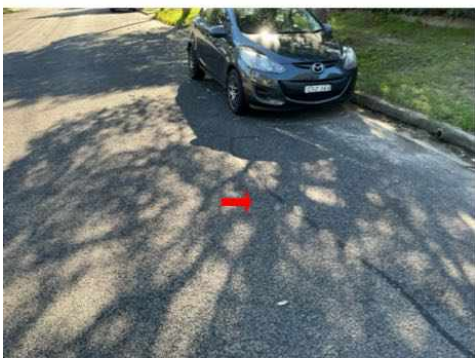
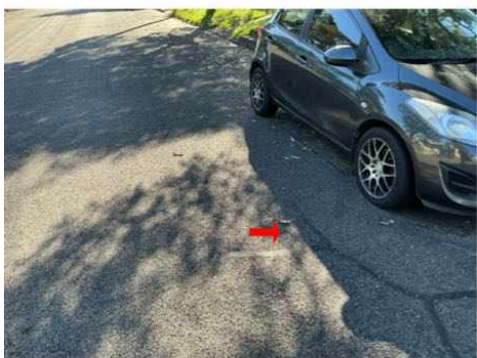
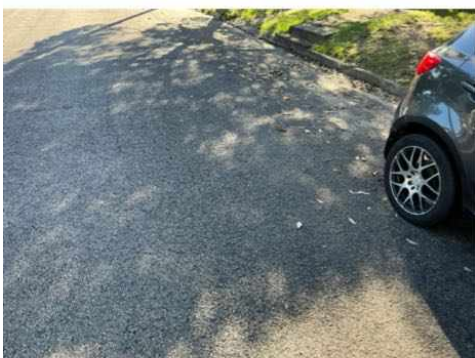
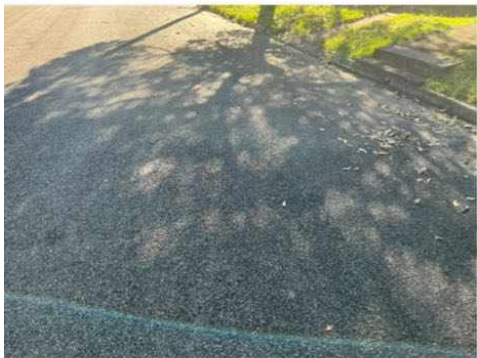
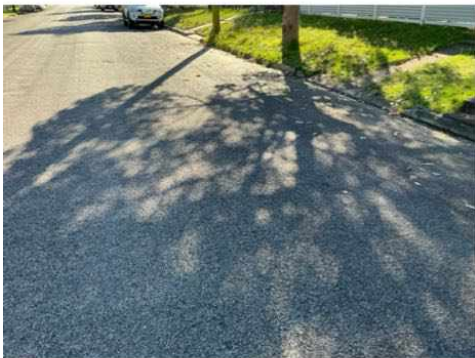
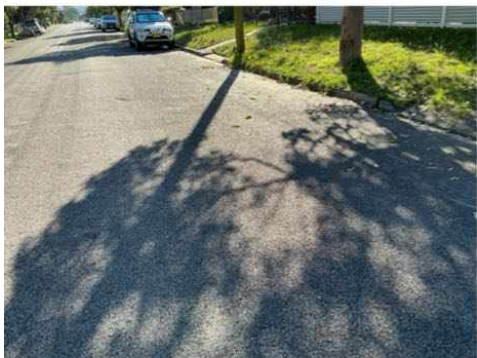
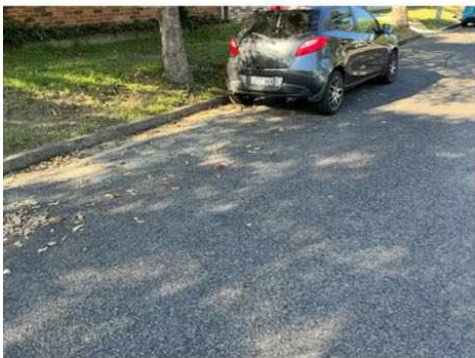
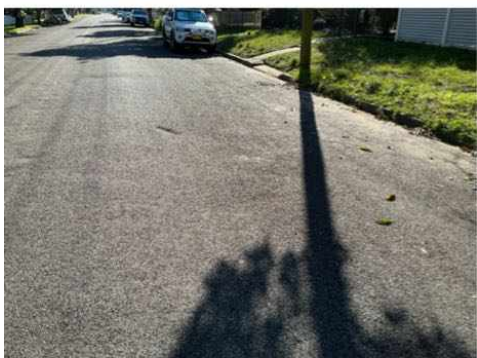
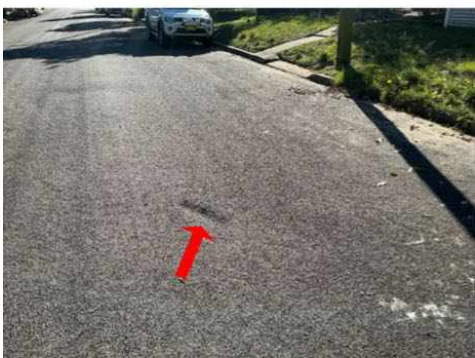
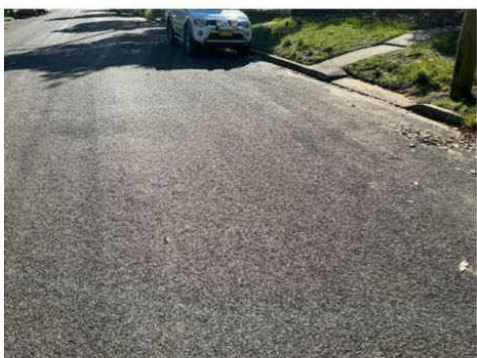
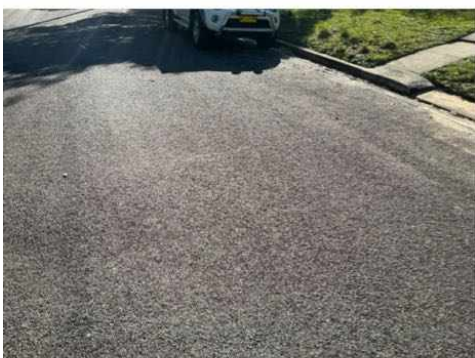
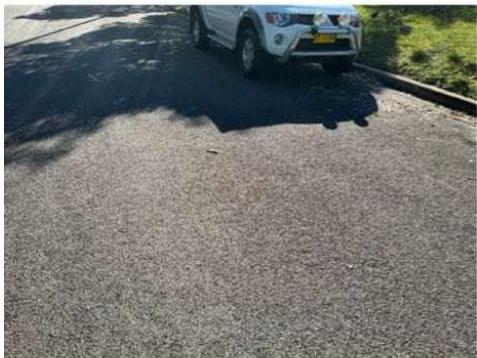
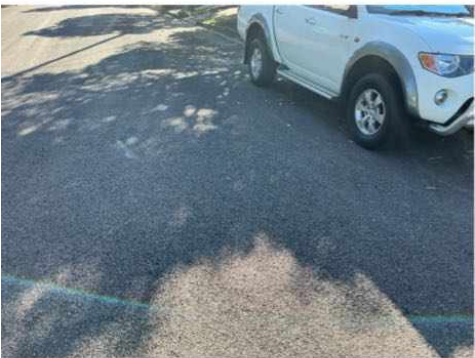
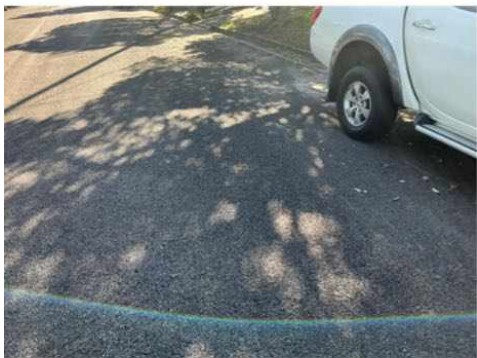
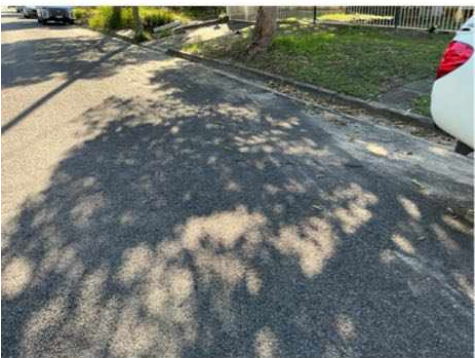
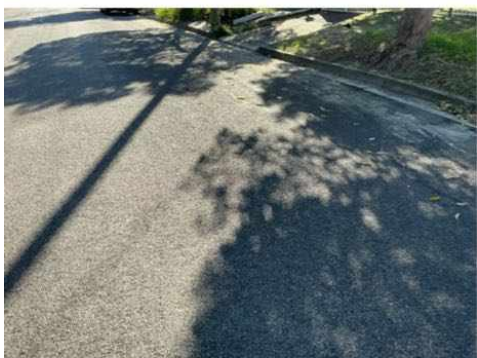
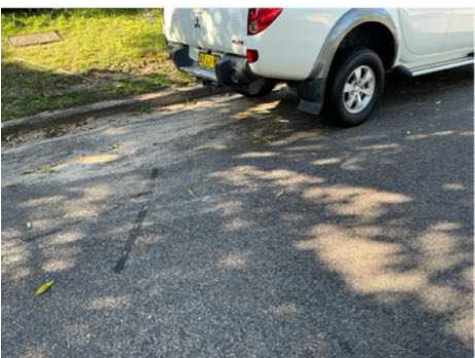
| Finding: | Roadway Asphalt (Dilapidation) |
| Information: | <p>At the front of the property there were clear signs of minor cracking and 'spiderwebbing' to the asphalt in the area at the time of inspection.</p> <p>This type of cracking is often consistent with general dilapidation of the area, and may continue to develop if left unmaintained.</p> <p>At the time of the inspection, the cracking in this area is in varying sizes and widths as noted in these images. Frequent monitoring should be carried out to identify any further damage.</p> |

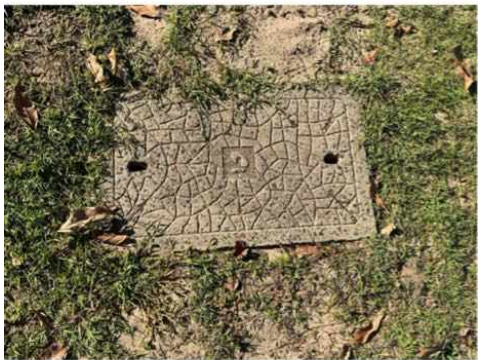
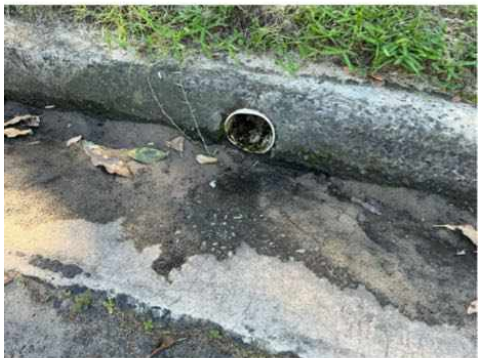
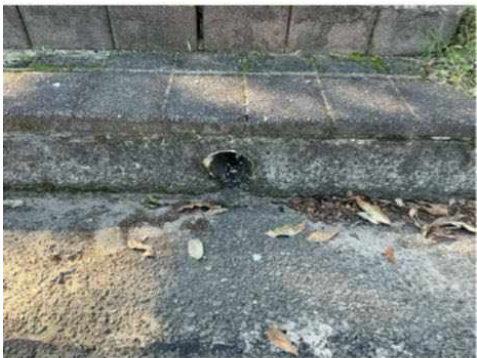
| Finding: | Service Pits/Drains Condition (Dilapidation) |

This type of subsiding is often consistent with general dilapidation of the property, and may continue to develop if left unmaintained.

At the time of inspection, the service pits are as per the photos attached. Frequent monitoring should be carried out to identify any further damage.
