## Dilapidation Inspection Report

Inspection Date: Thu, 9 Apr 2026

Property Address: 30 Beach St, Ettalong Beach NSW 2257,  
Australia

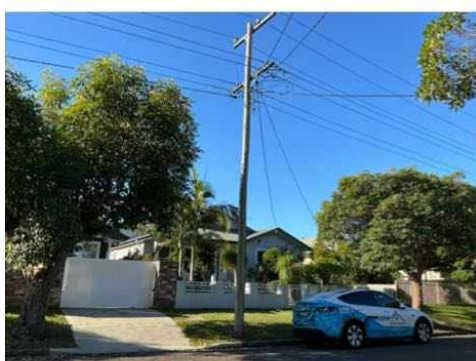
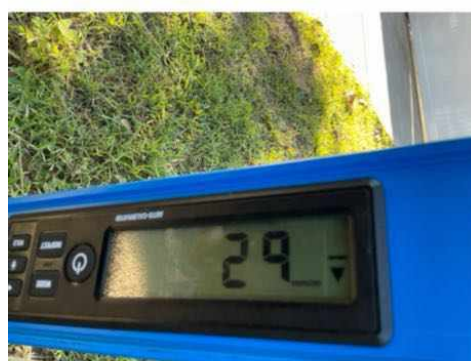
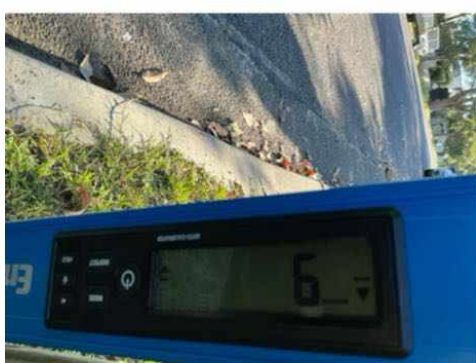
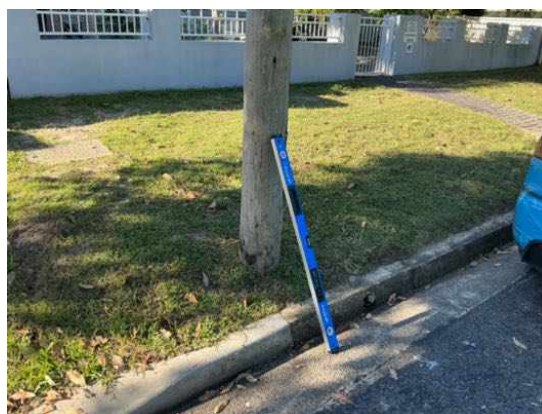
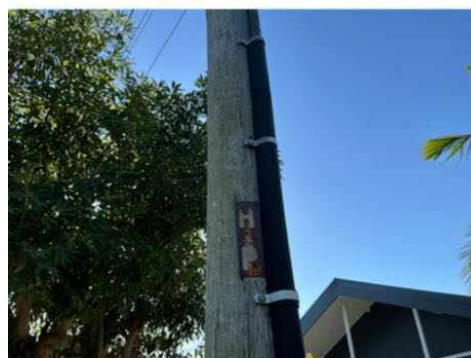
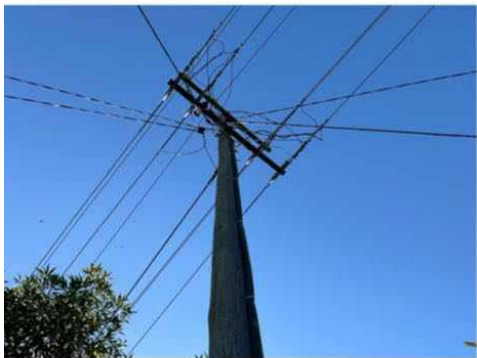
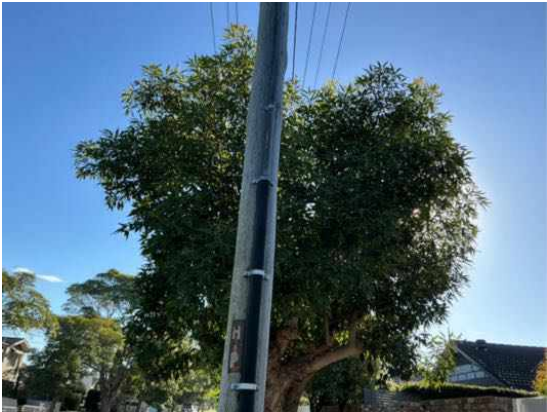
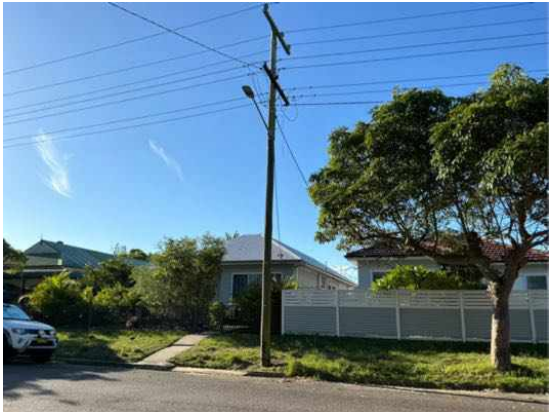
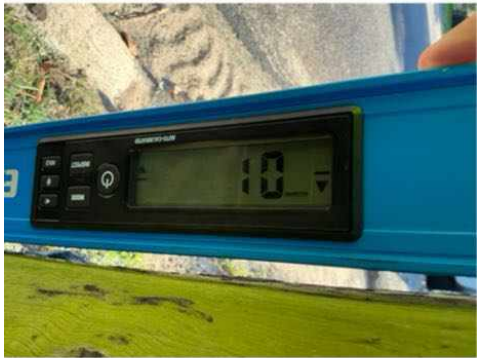
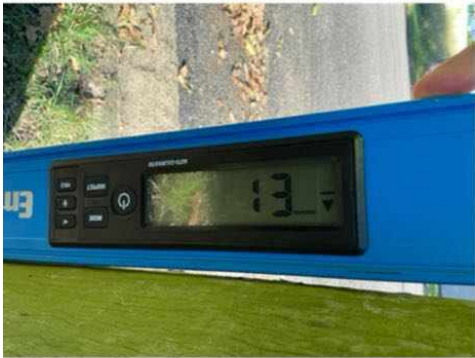
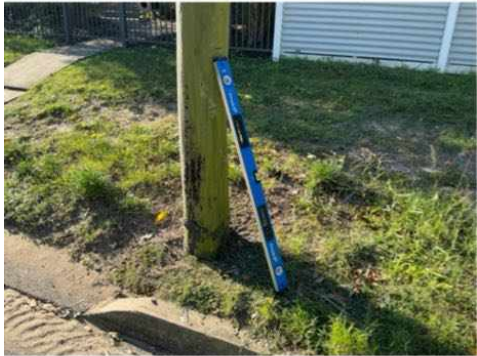
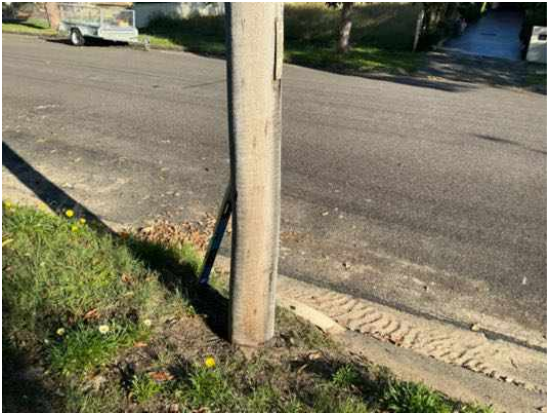
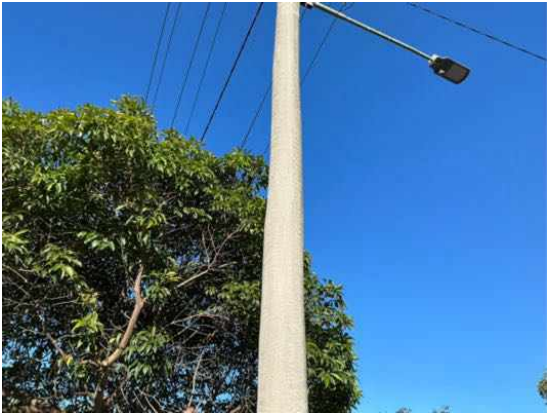
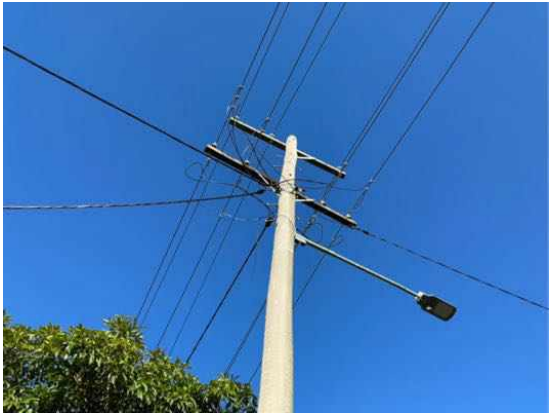
| Information: | <p>The telegraph poles along the street were visually inspected as part of this dilapidation report. Observations were limited to accessible and visible aspects of the poles and excluded any underground or concealed structural elements. The condition of the telegraph poles varied, with some displaying general wear and deterioration consistent with exposure to environmental factors such as weathering, moisture, and UV exposure.</p> <p>Common observations included surface wear, minor cracking, peeling or faded</p> |

protective coatings, and localised areas of staining or discolouration. In some cases, evidence of rust on metal components or minor degradation at the base of the poles was noted, which may warrant further investigation. No significant structural defects or immediate safety concerns were identified at the time of inspection.

This assessment is based on a visual inspection only and reflects the condition of the telegraph poles at the time of the report. Regular monitoring and maintenance by the responsible authority are recommended to ensure the ongoing safety and functionality of the poles. Photographic evidence has been included to document the condition of the poles and highlight any areas of concern.

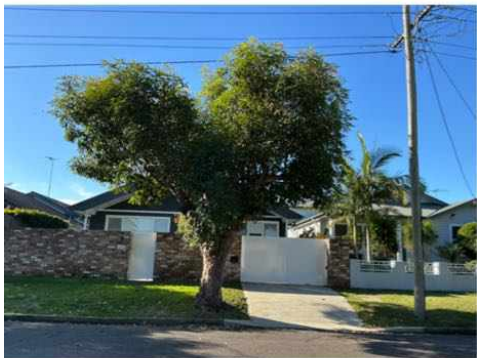
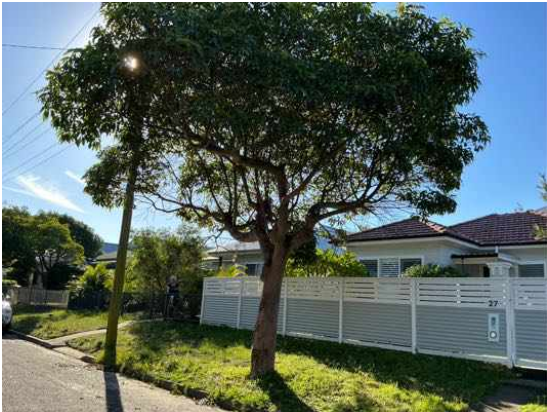
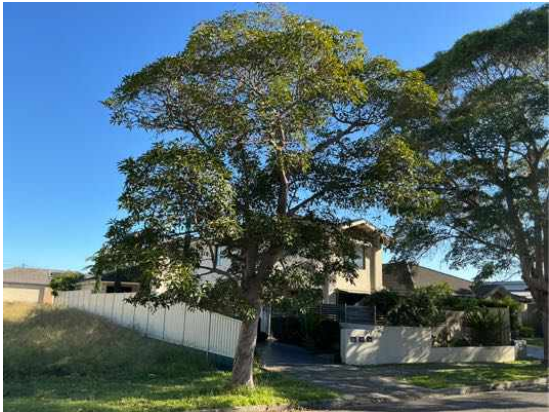
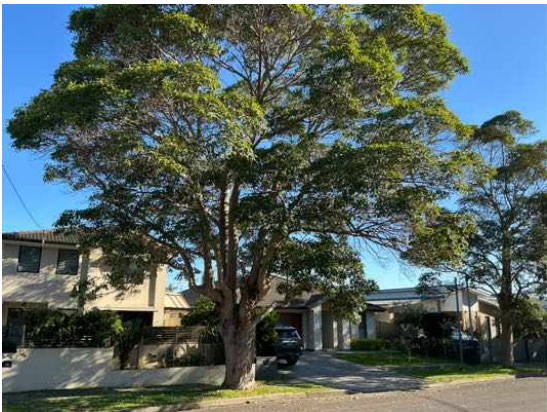
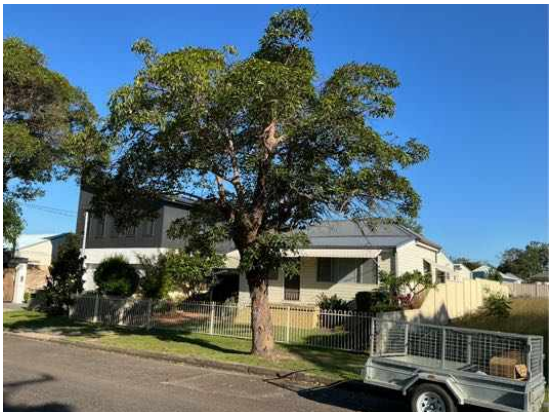
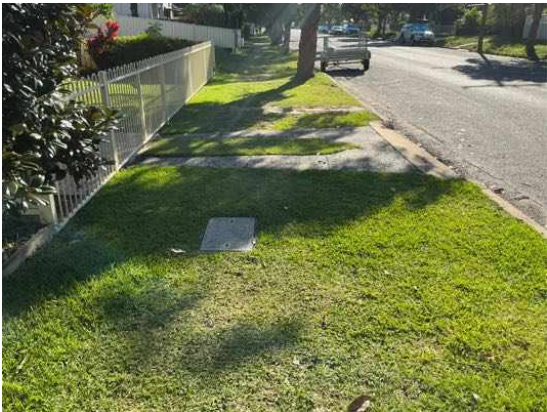
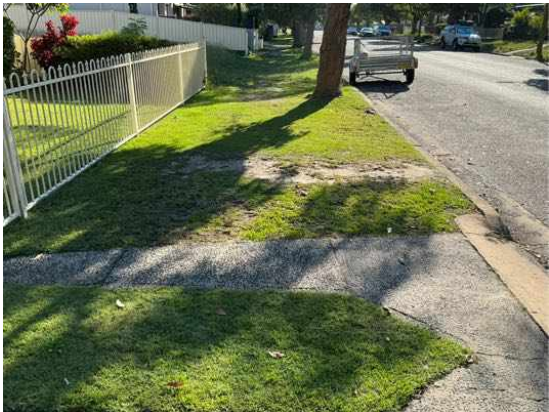
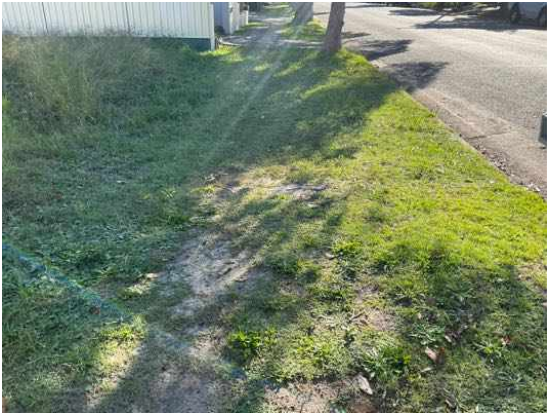
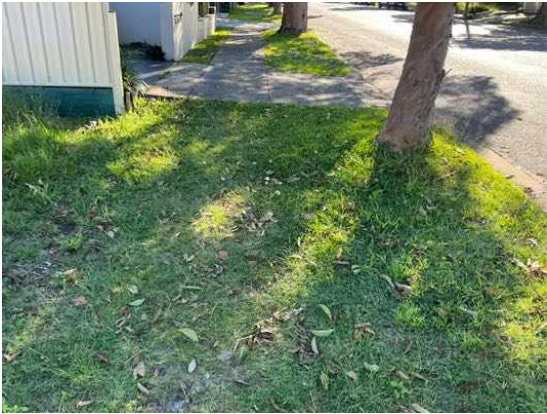
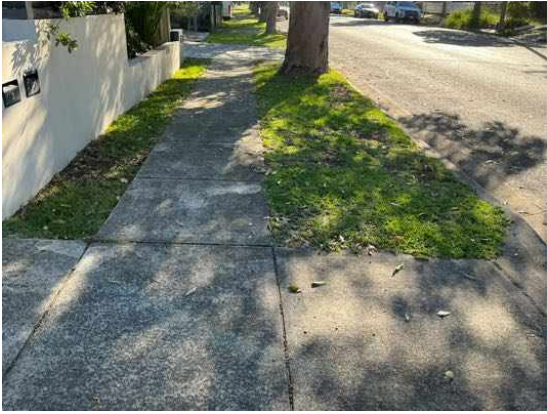
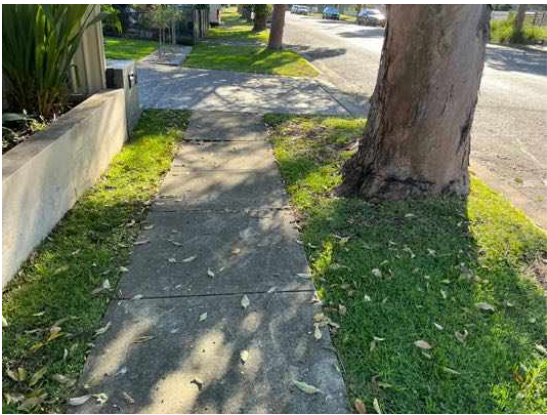
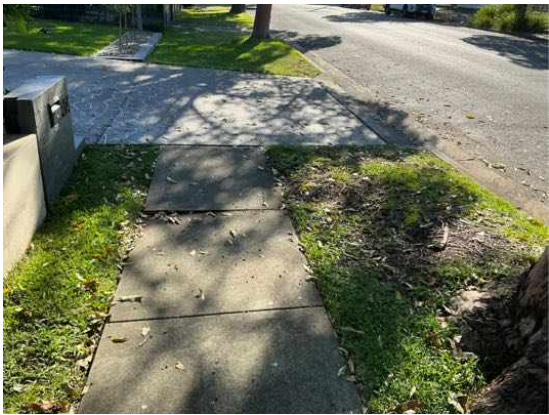
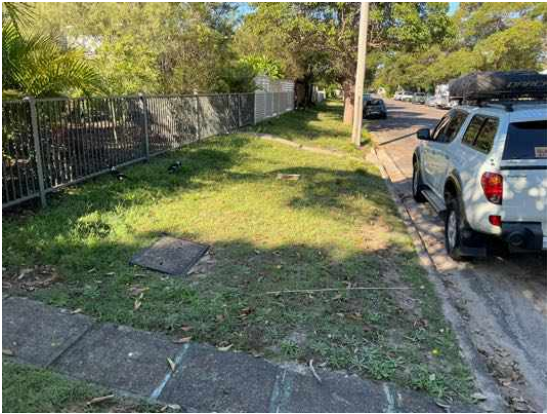
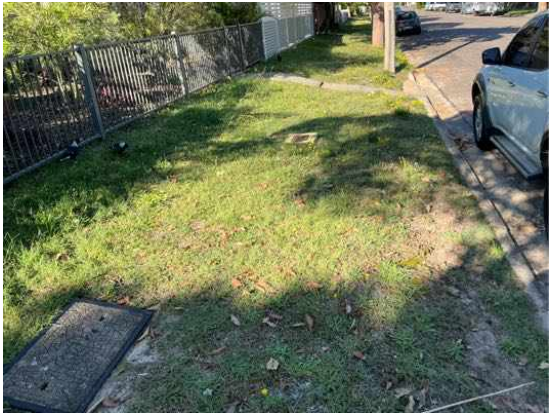
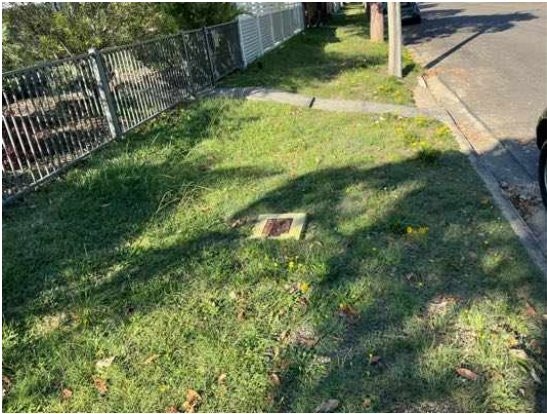
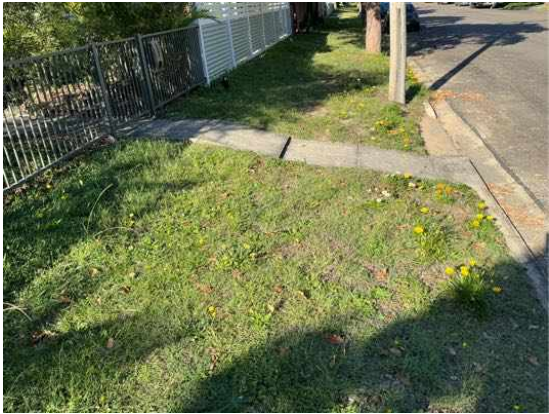
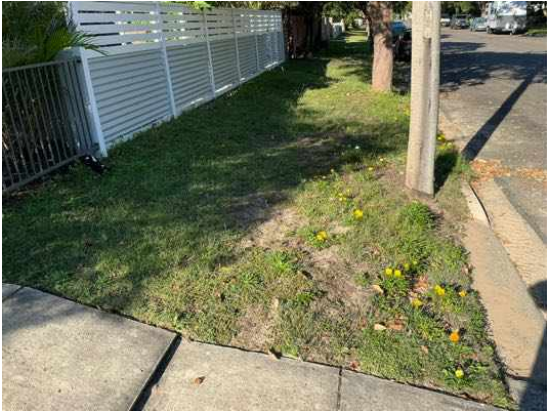
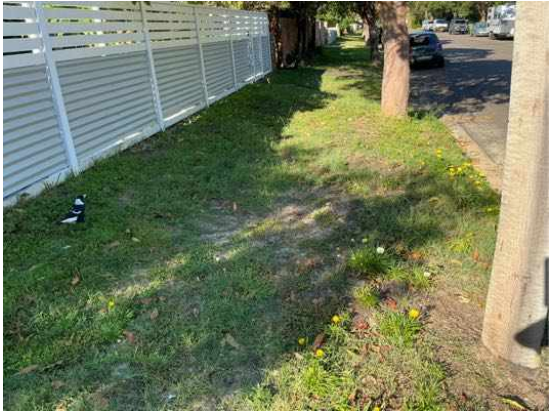
| Information: | The trees, plants, and garden beds outside the property were visually inspected as part of this dilapidation report. Observations were limited to visible conditions and excluded subsurface or root system issues. Minor wear consistent with age and environmental exposure was noted, including displaced soil, dead branches, and natural pruning. Regular maintenance, including trimming and soil care, is recommended. Photographs have been included to highlight areas of note. |

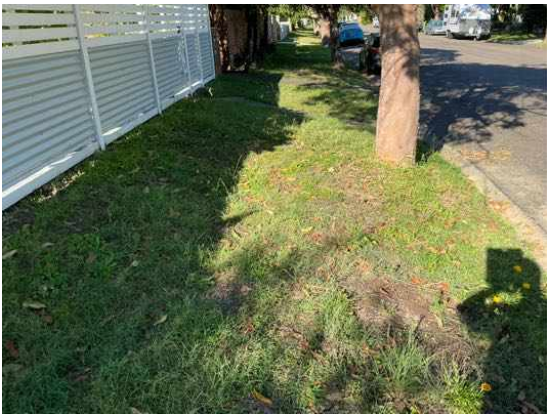
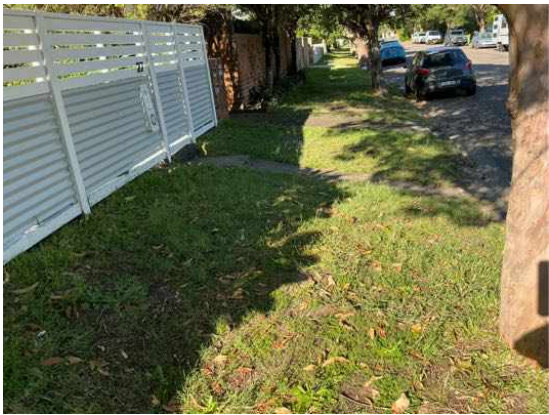
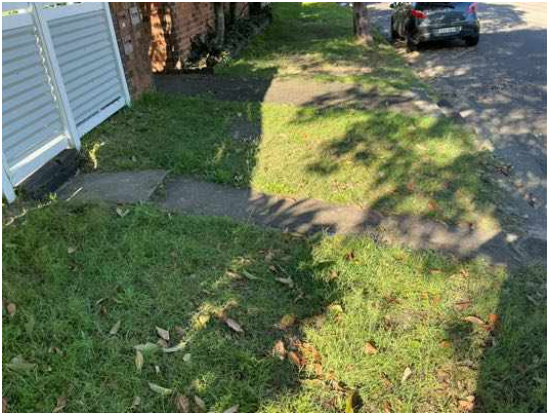
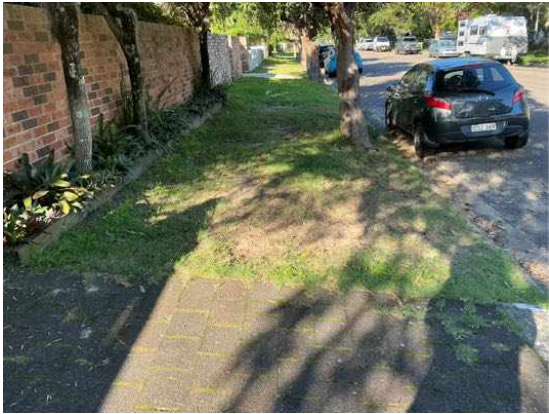
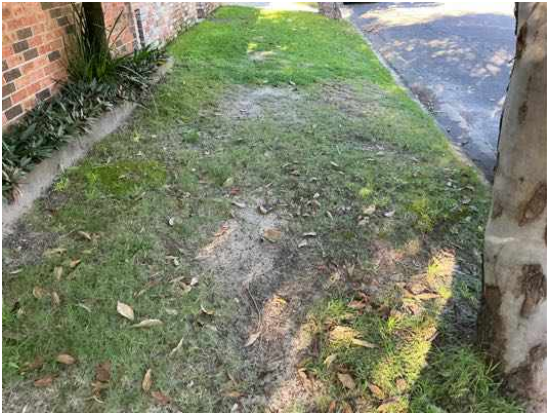
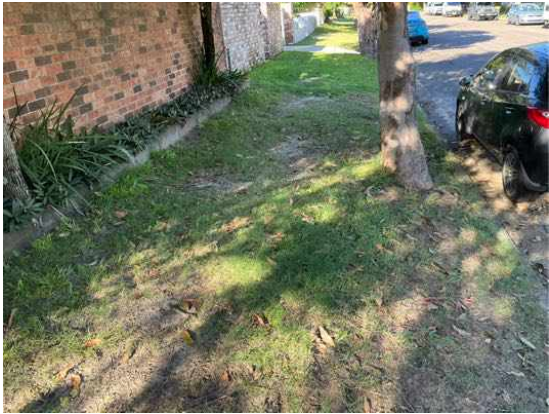
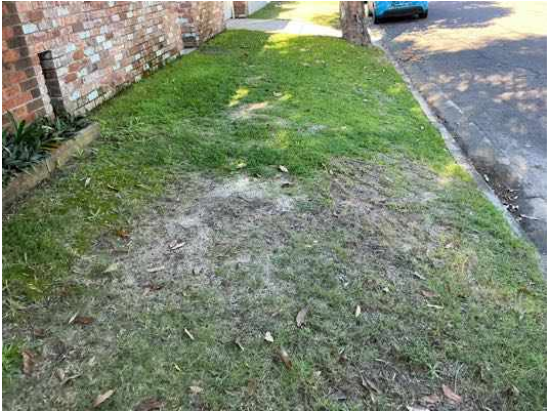
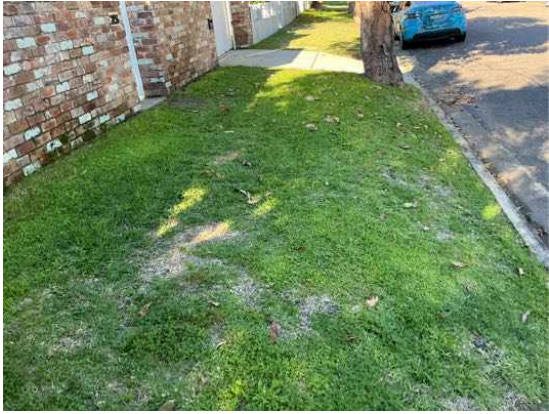
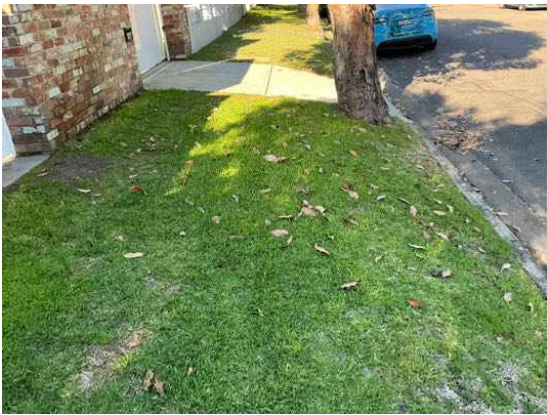
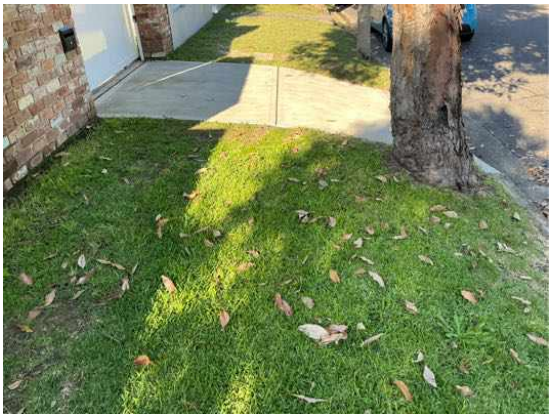
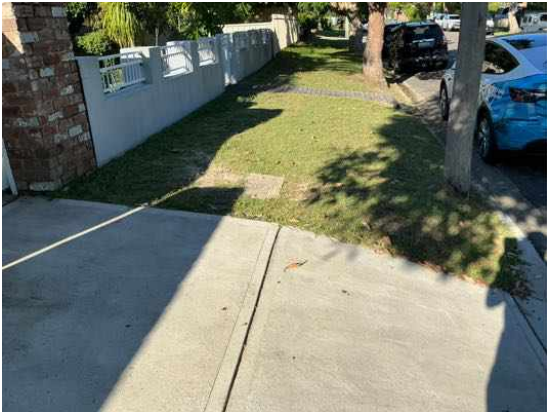
| Finding: | Trees, Plants, Garden Beds Condition |

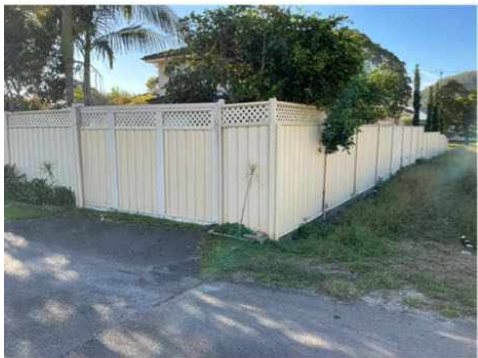
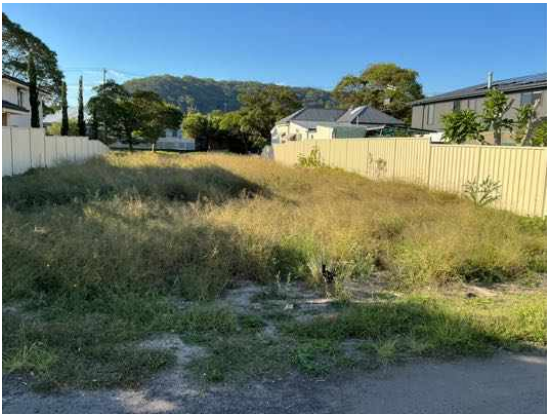
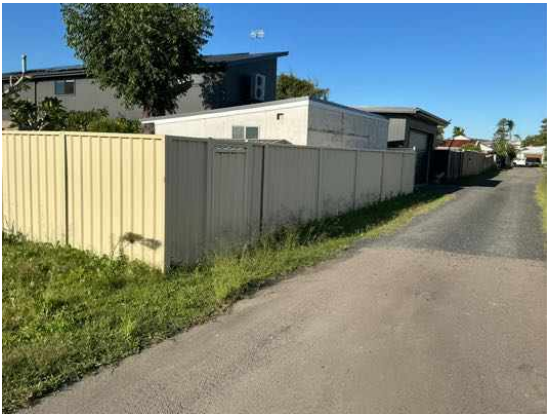
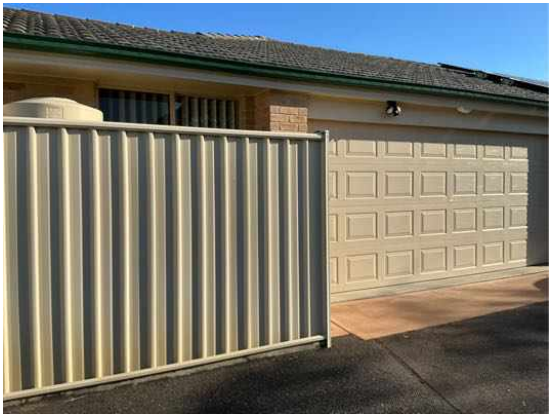
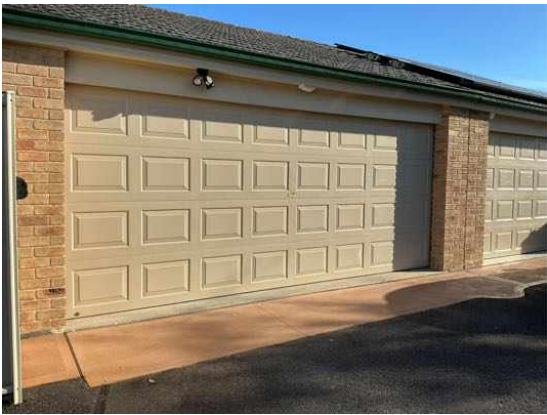
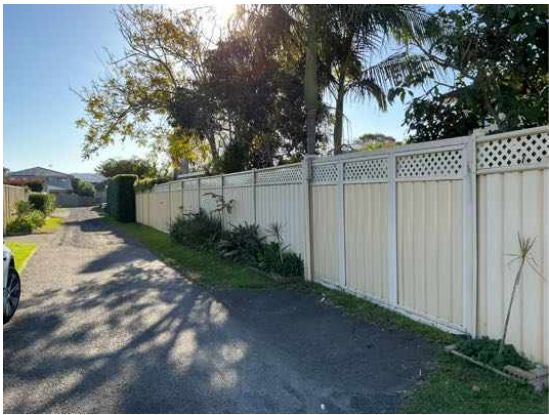
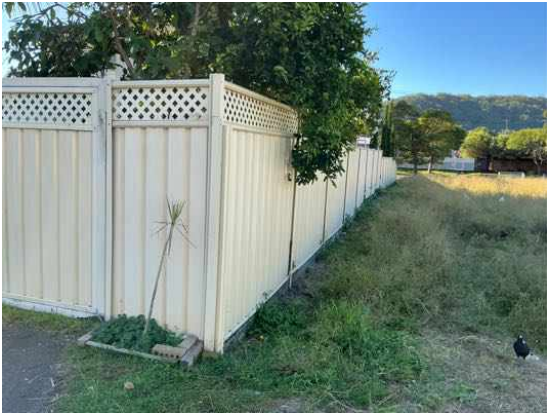
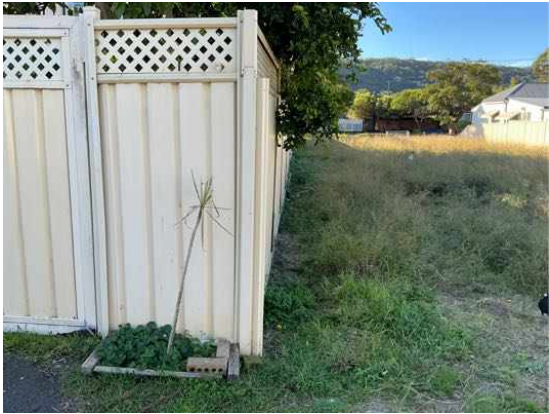
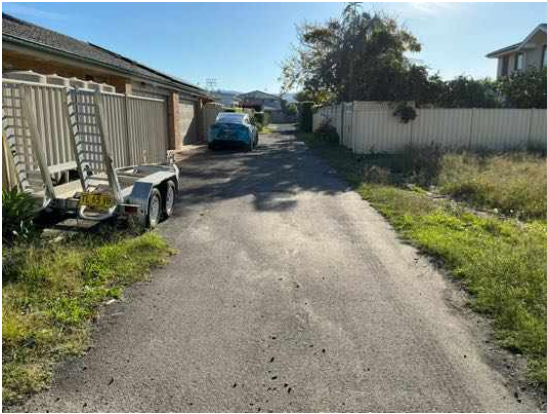
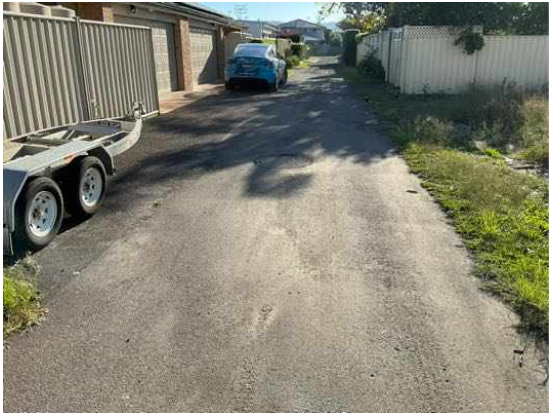
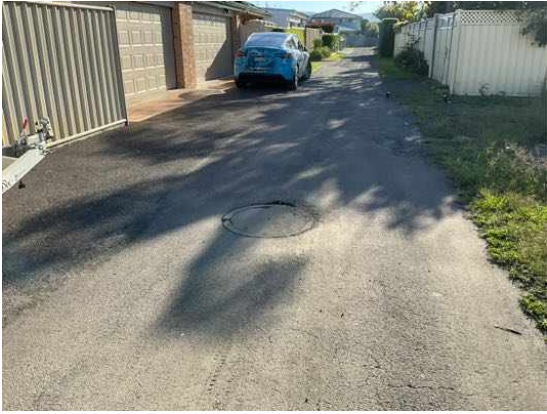
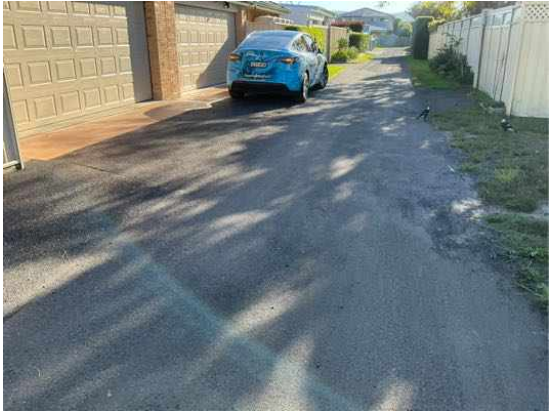
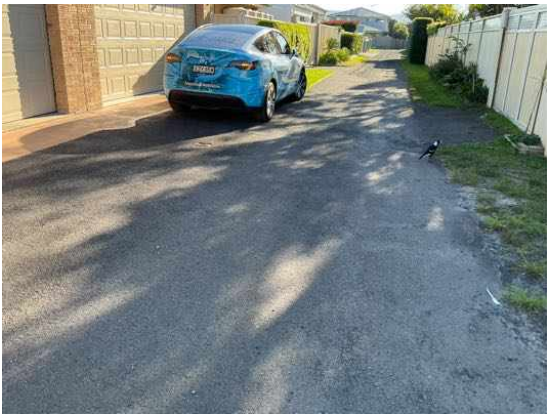
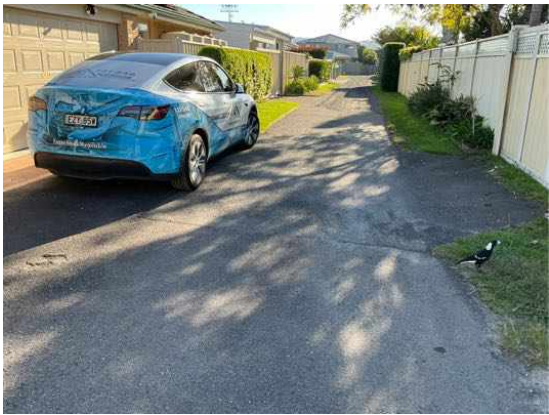
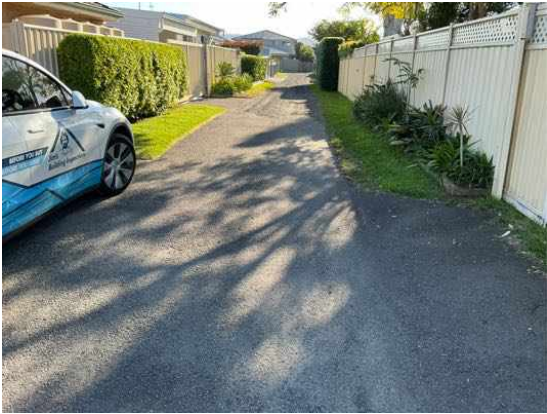
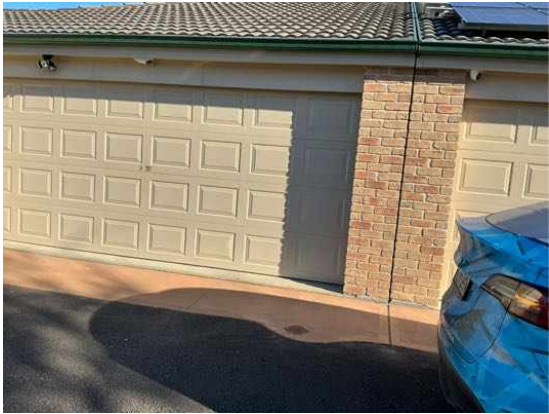
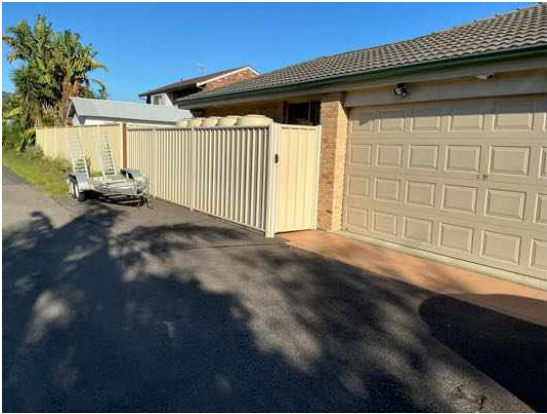
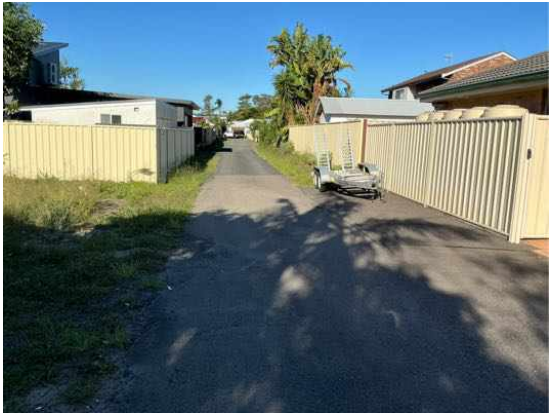
Building: Main Building  
Location: Back Lane  
Finding: FYI – General Condition of Back Lane  
Information: At the time of inspection, the back lane including roadways, fencing, and surrounding elements appeared to be in generally serviceable condition with typical signs of wear and tear noted.

These observations are provided for documentation purposes as part of the dilapidation report. The client is advised to monitor these areas during and after any nearby construction works to identify any changes or damage that may occur.
