Arborist Report

Client: Bayside Central Pty Ltd

Address: 40 Bogan Road,

BOOKER BAY N.S.W 2257

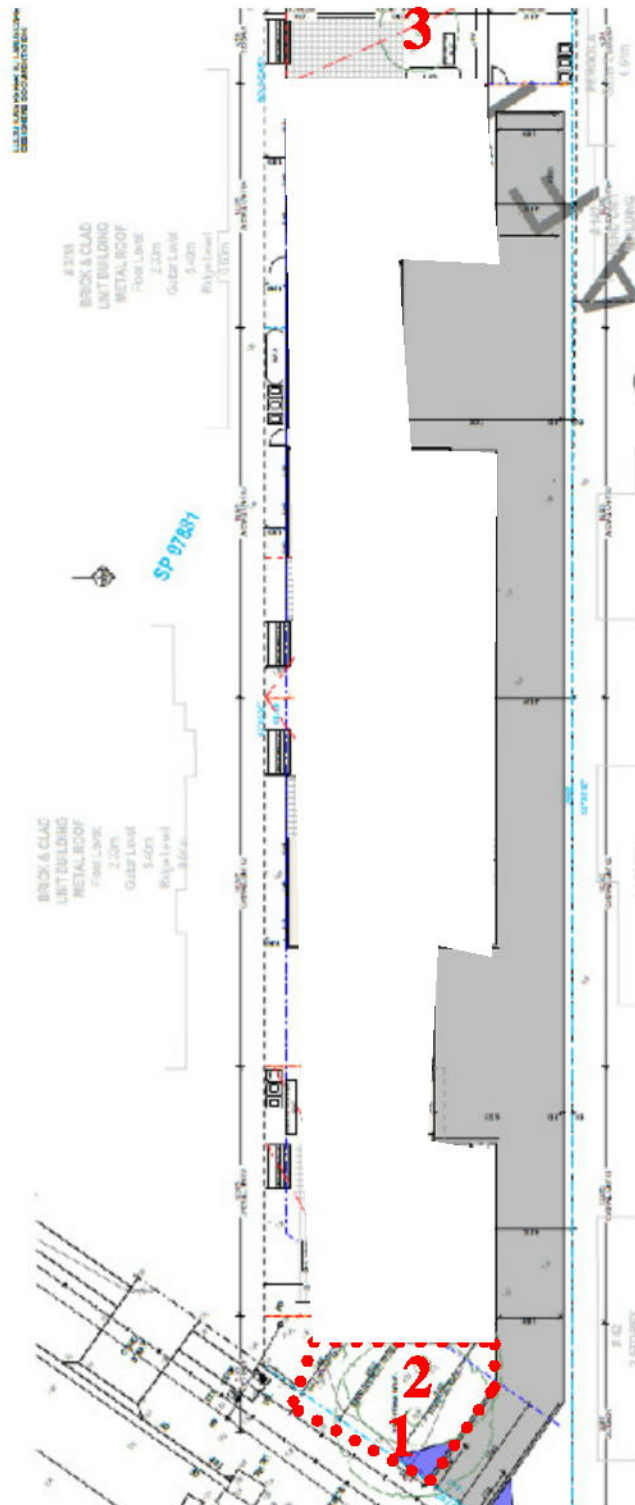
Figure 7 - Close up of the subject property and canopy area of Trees 1 - 3. The red hashed area represent the protection fencing. Not to scale
Source: ELK Designs

- It is recommended that protection measures be put in place that aid in the preservation of Tree 1 (1 in total). It is recommended that 1.8 metre inter locking chain wire fencing be installed before commencement of building works on site as indicated in Figure 6. Protection fencing is to be installed to the edge of the proposed driveway within the TPZ. The fencing is to extend to the proposed veranda and continue to the edge of the TPZ to the northern quadrant. Fencing to the western side will be located at the boundary and connect with the other two sides as indicated in Figure 7. Protection fencing is to be installed before commencement of all civil & building works and remain in place until the release of the occupation certificate.
